# **NON PERFORMANCE BORESCOPE INSPECTION**

## **CFM 56 -3C1 ESN856131**

| Inspection Date: | 07-17-2026 |

FINDINGS : CC CHAMBER DAMAGE OUT OF LIMIT  
IAW AMM 72-00-00-216-022--C00

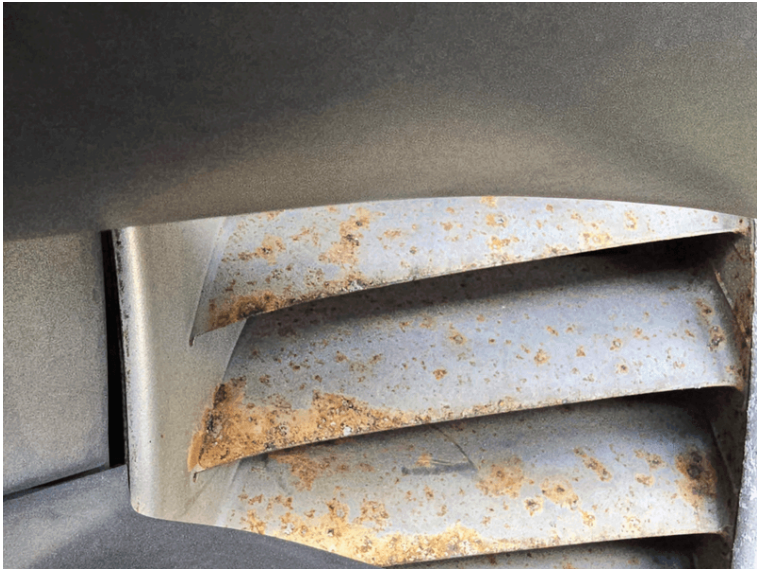
INLET  
INLET

Review Minor  
2 STATOR VANES INLET  
Slightly corrosion on leading edge

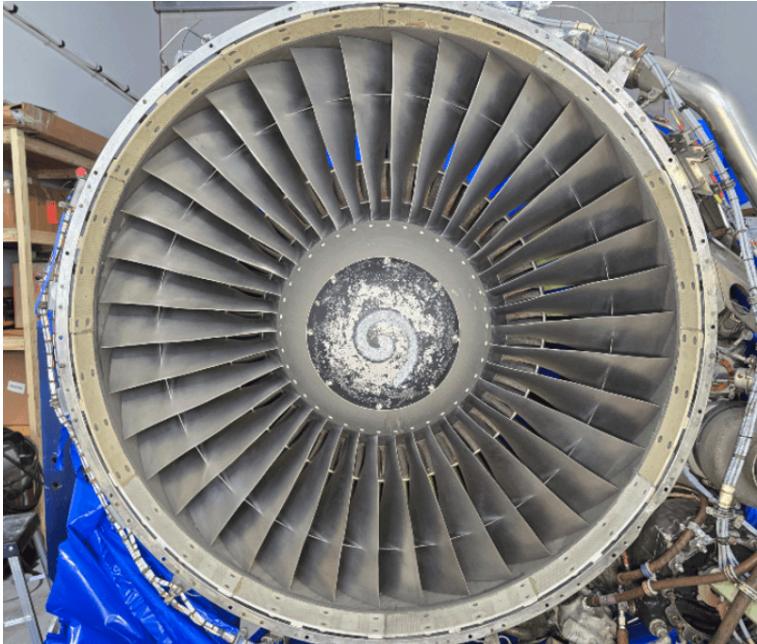
INLET  
INLET

No Mark  
0 FAN ASSY  
NO DAMAGE FOUND

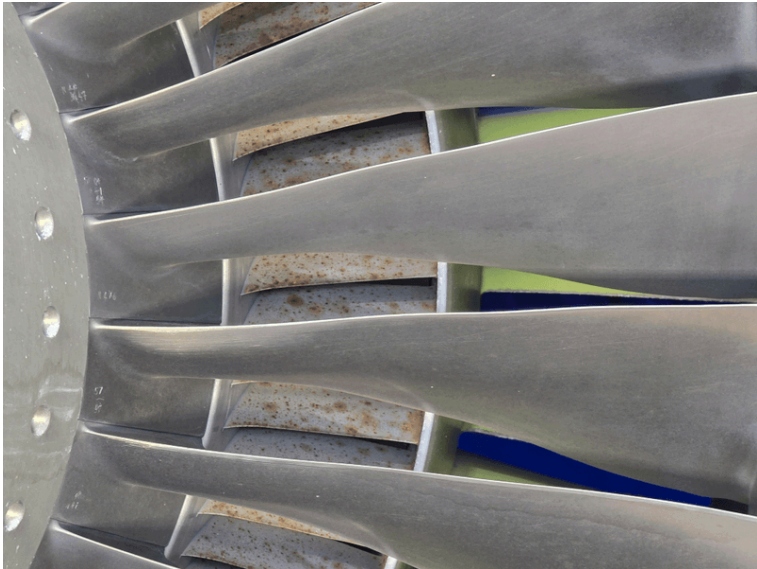
INLET  
INLET

Accepted

1 FAN BLADES  
No damage Found on blades

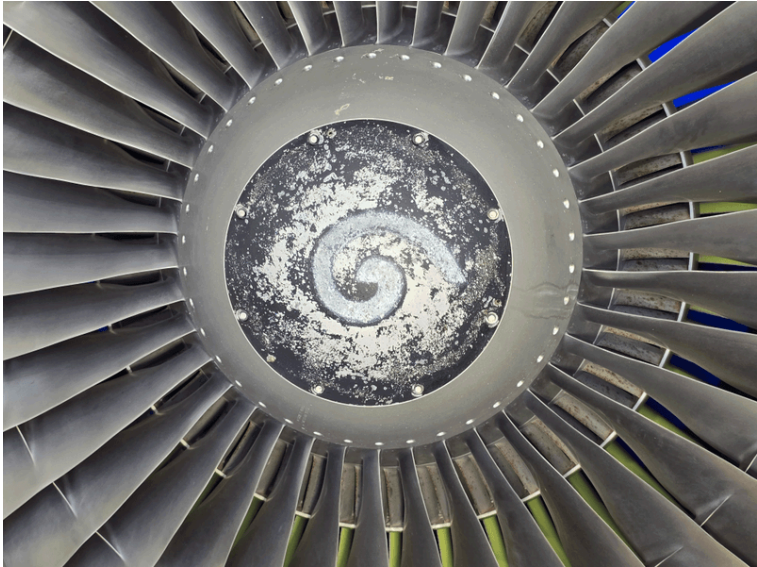
INLET  
INLET

0 FAN BLADES  
NO DAMAGE FOUND ,

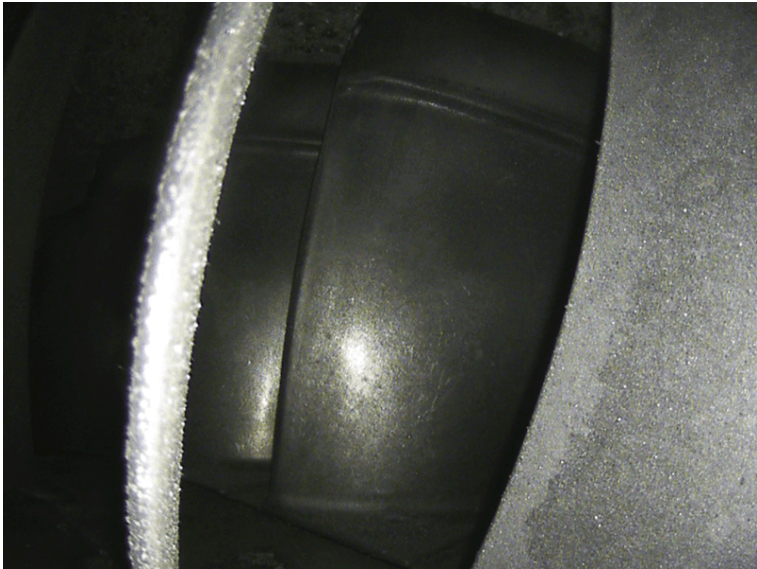
HPC  
Stage 01  
LeadingEdge

NO DAMAGE FOUND  
Dust Observed

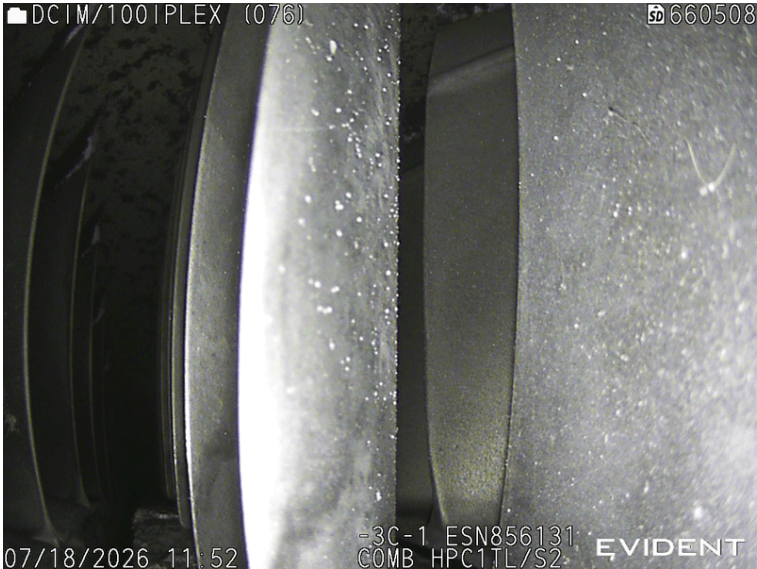
HPC  
Stage 01  
TrailingEdge

NO DAMAGE FOUND  
Dust and Moisture Observed

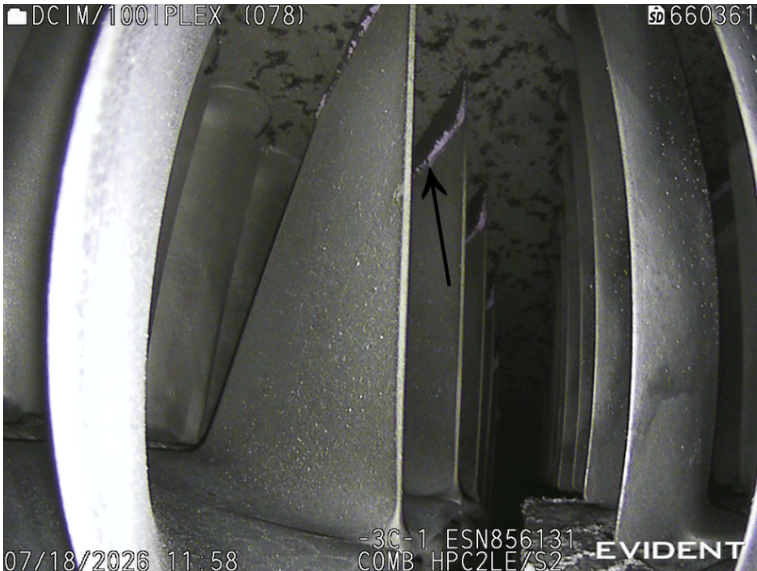
HPC  
Stage 02  
LeadingEdge

Accepted  
-3C-1 ESN856131COMB  
HPC2LE/S2  
NO DAMAGE FOUND  
Dust and Moisture Observed

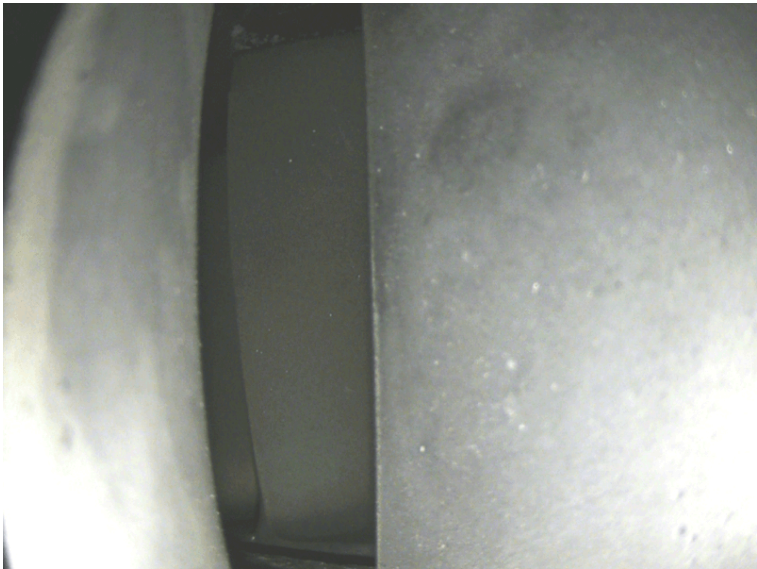
HPC  
Stage 02  
TrailingEdge

Accepted  
-3C-1  
ESN856131HPC2TE/S3  
NO DAMAGE FOUND  
Dust Observed

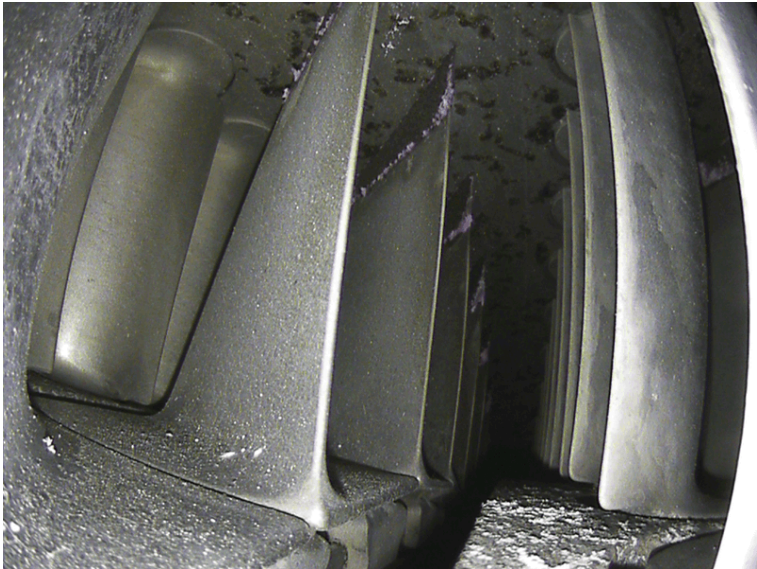
HPC  
Stage 03  
LeadingEdge

NO DAMAGE FOUND

Dust and Moisture observed

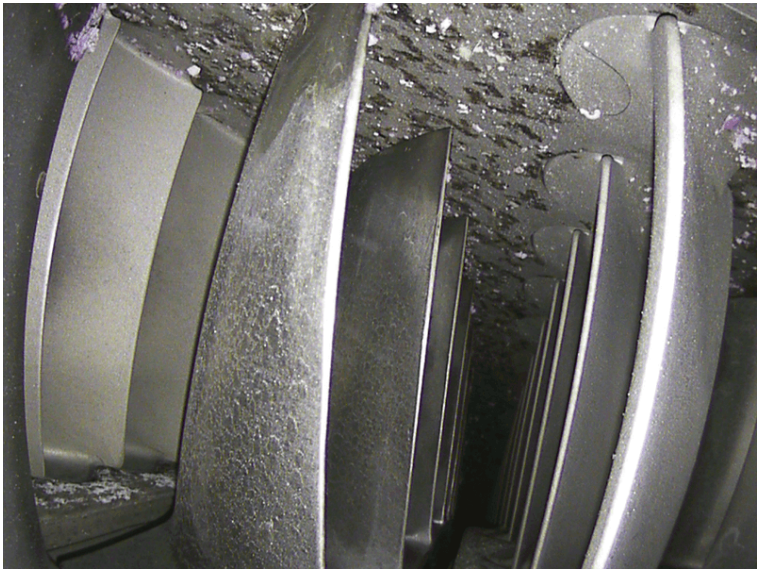
HPC  
Stage 03  
TrailingEdge

NO DAMAGE FOUND.

Dust and Moisture Observed

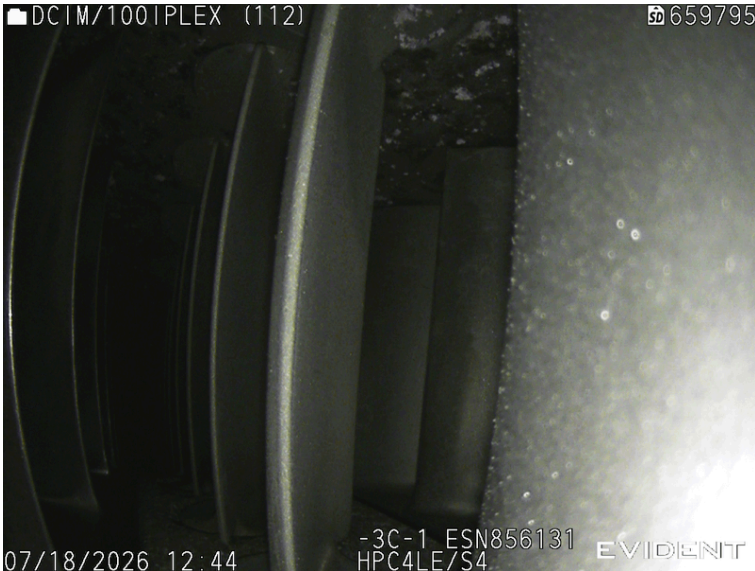
HPC  
Stage 04  
LeadingEdge

Accepted  
-3C-1  
ESN856131HPC4LE/S4  
NO DAMAGE FOUND  
Dust and Moisture Observed

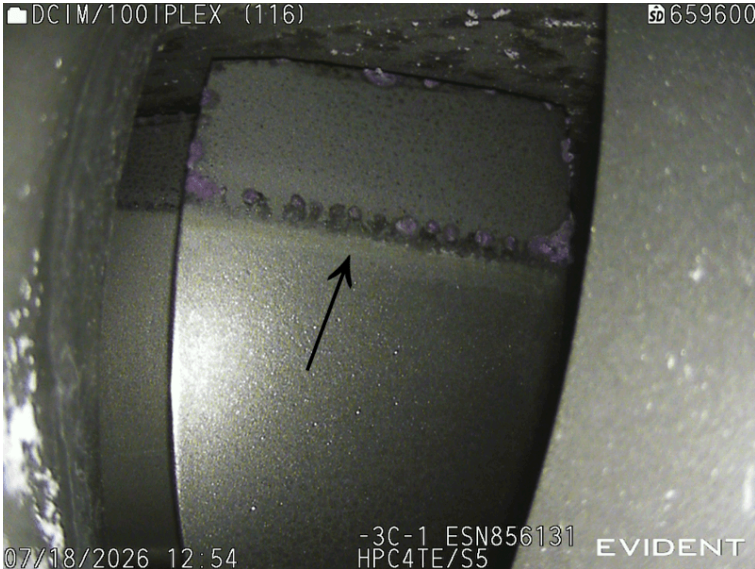
HPC  
Stage 04  
TrailingEdge

Accepted  
-3C-1  
ESN856131HPC4TE/S5  
NO DAMAGE FOUN  
Dust and Moisture Observed

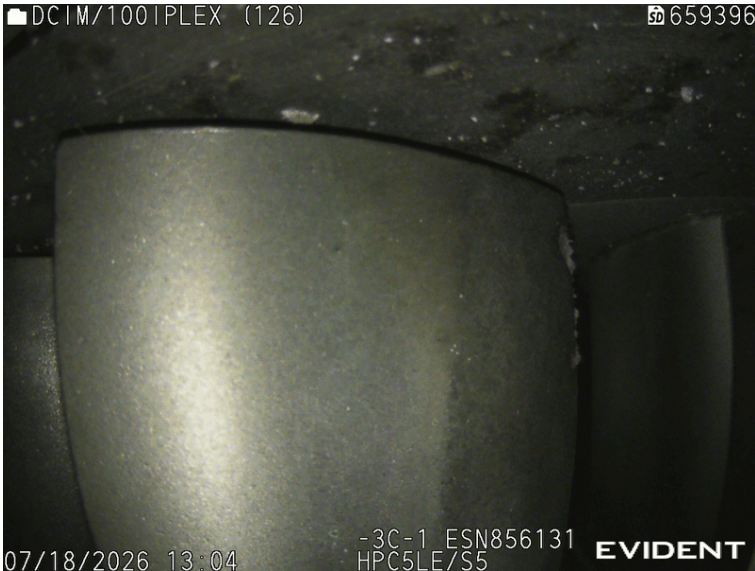
HPC  
Stage 05  
LeadingEdge

NO DAMAGE FOUND  
Dust and Moisture Observed

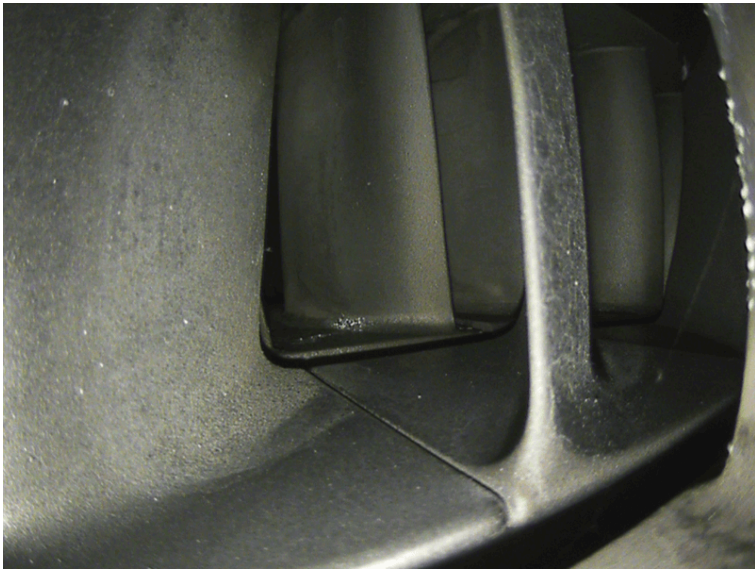
HPC  
Stage 05  
LeadingEdge

NO DAMAGE FOUND

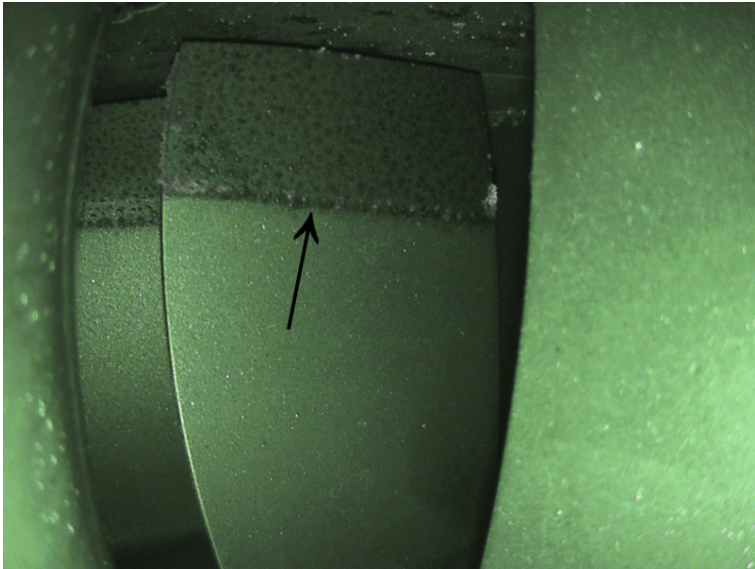
HPC  
Stage 05  
TrailingEdge

NO DAMAGE FOUND  
Dust and Moisture Observed.

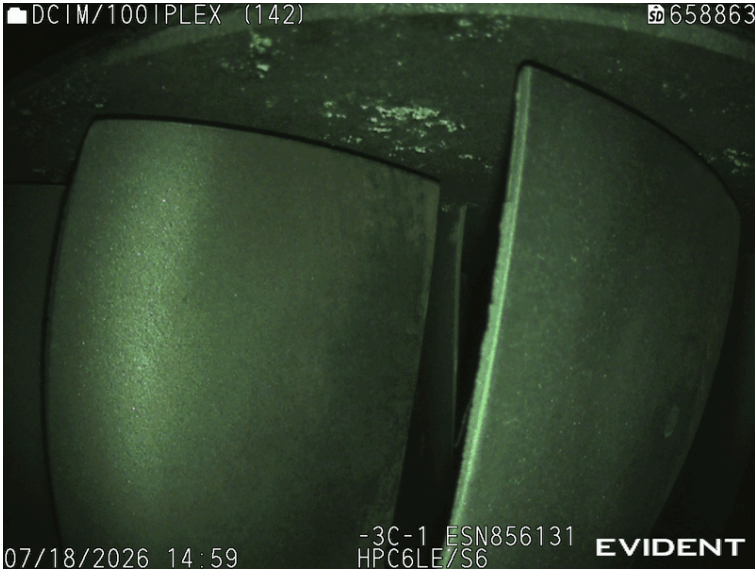
HPC  
Stage 06  
LeadingEdge

NO DAMAGE FOUND

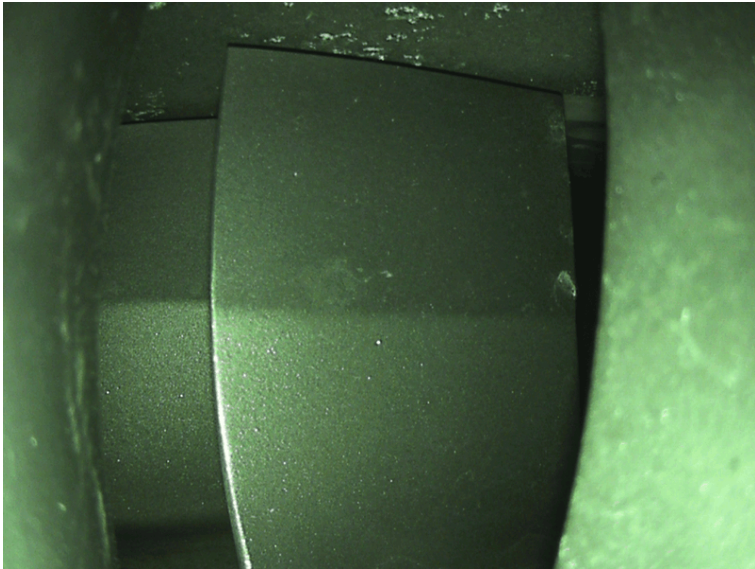
HPC  
Stage 06  
TrailingEdge

Accepted  
-3C-1  
ESN856131HPC6TE/S7  
NO DAMAGE FOUND

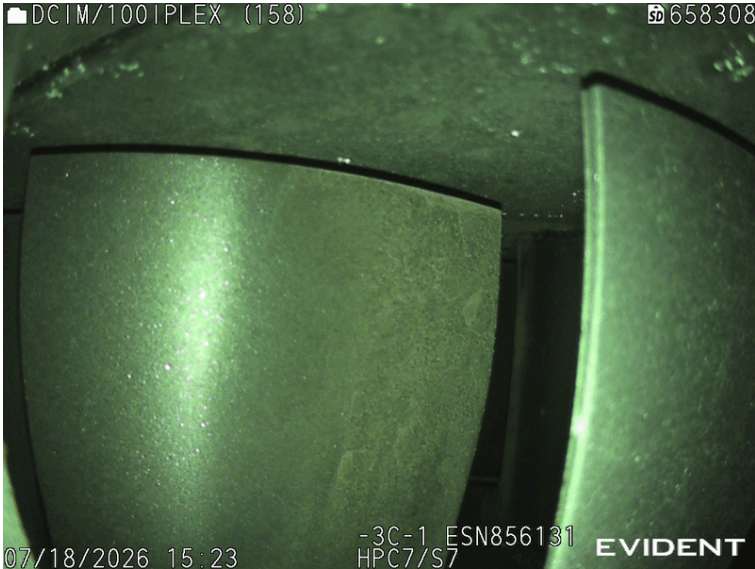
HPC  
Stage 07  
LeadingEdge

Accepted  
-3C-1 ESN856131HPC7/S7  
NO DAMAGE FOUND

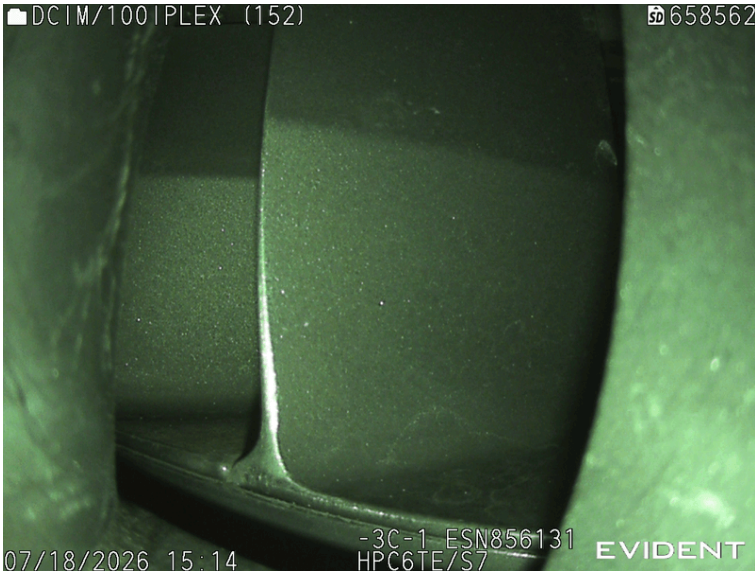
HPC  
Stage 07  
TrailingEdge

Accepted  
-3C-1  
ESN856131HPC6TE/S7  
NO DAMAGE FOUND

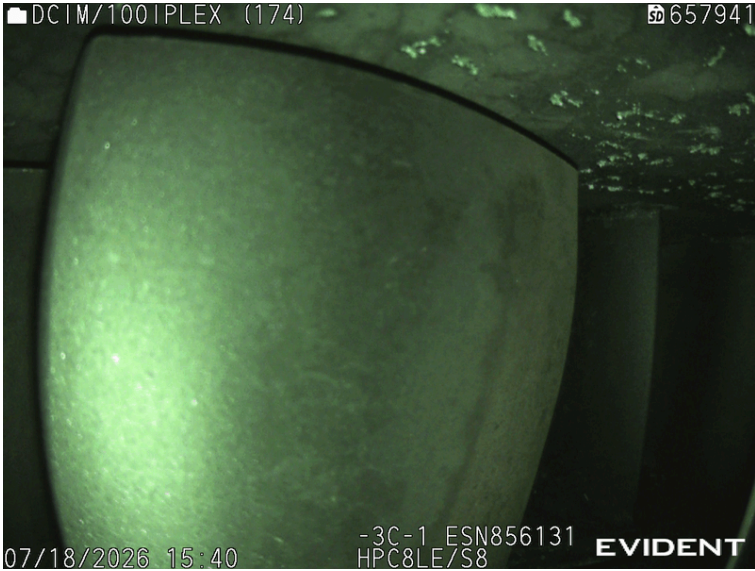
HPC  
Stage 08  
LeadingEdge

Accepted  
-3C-1  
ESN856131HPC8LE/S8  
NO DAMAGE FOUND

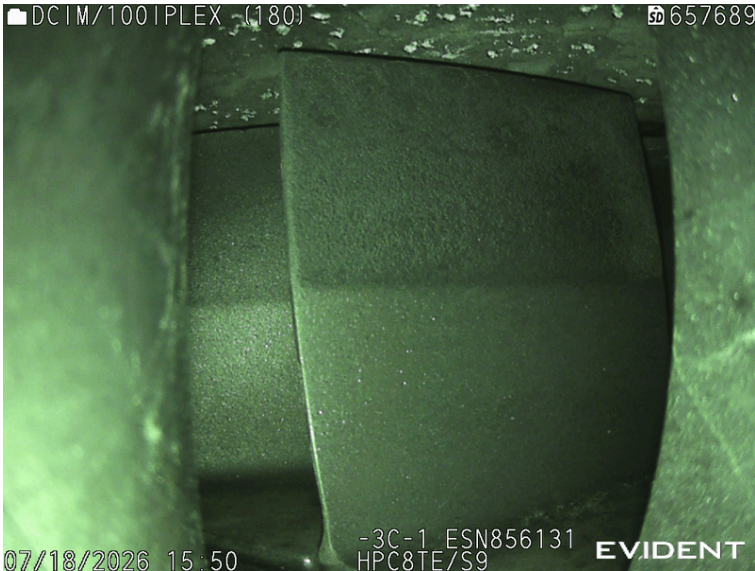
HPC  
Stage 08  
TrailingEdge

NO DAMAGE FOUND  
Dust and Moisture Observed

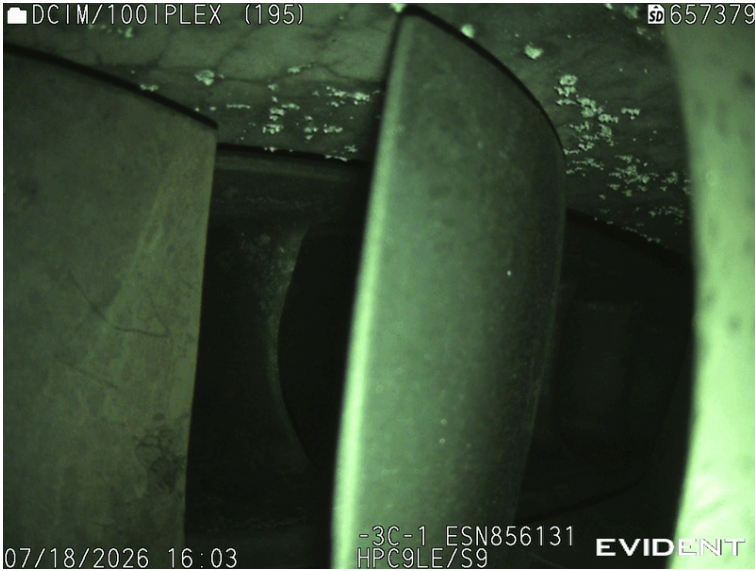
HPC  
Stage 09  
LeadingEdge

NO DAMAGE FOUND  
Dust and Moisture Observed

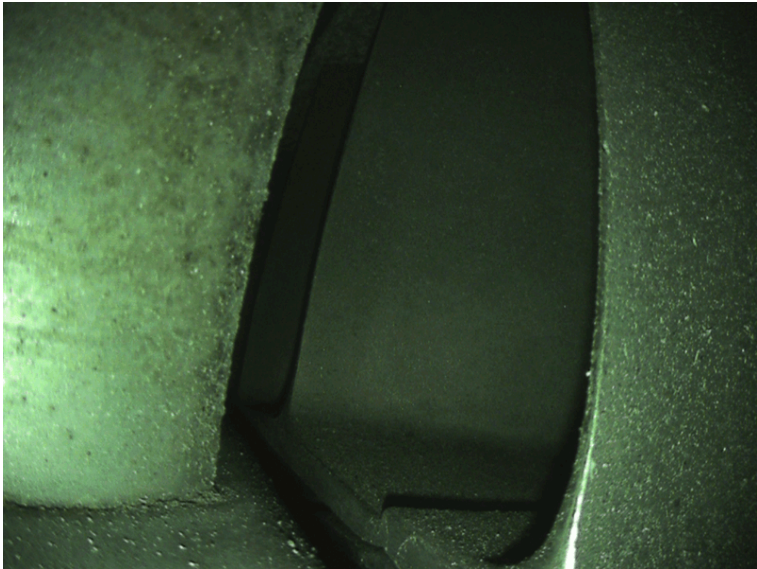
LPC  
Stage 03  
TrailingEdge

Accepted  
3C-1 SN856136 LPC3TE/S0  
1 NO DAMAGE FOUND  
Dust and Moisture Observed

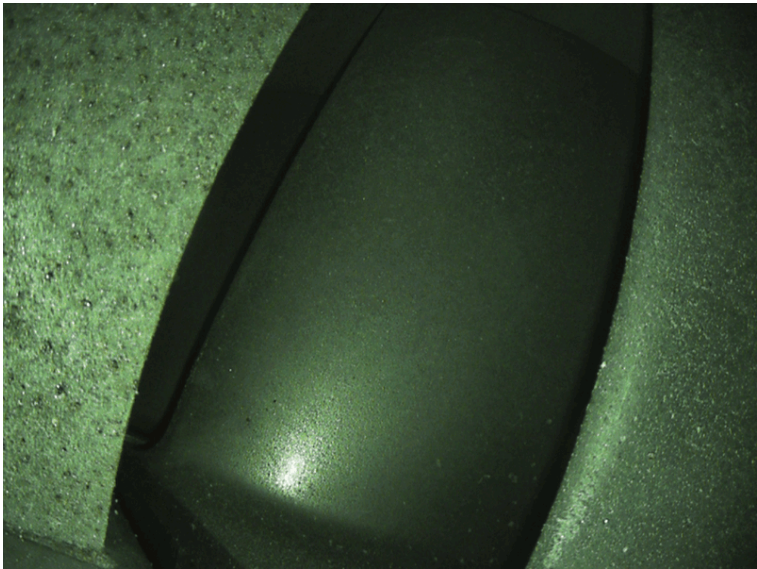
LPC  
Stage 04  
LeadingEdge

Accepted  
3C-1 SN856136 LPC4/S0  
1 NO DAMAGE FOUND  
Dust and Moisture Observed

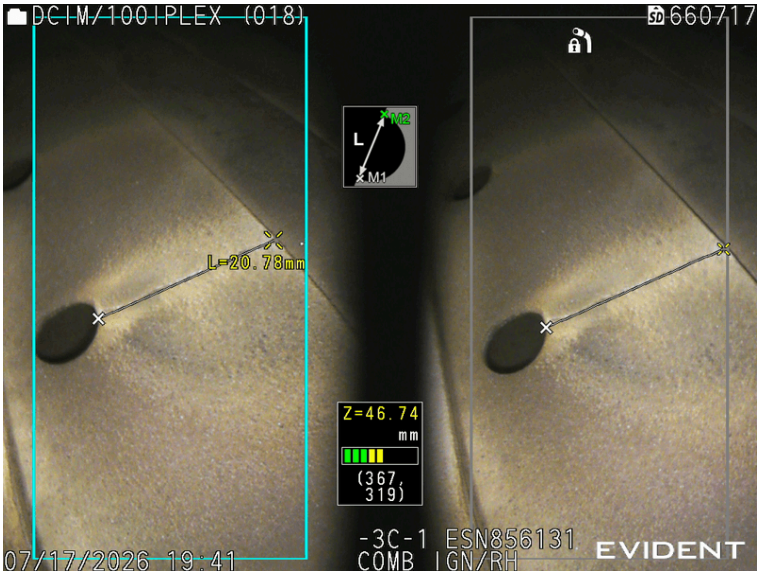
CC  
Combustion  
Chamber

Accepted

1 AXIAL CRACKS on the  
inner liner :  
Cracks that go across one  
panel or less are permitted  
IAW AMM 72-00-00-216-022-  
C00

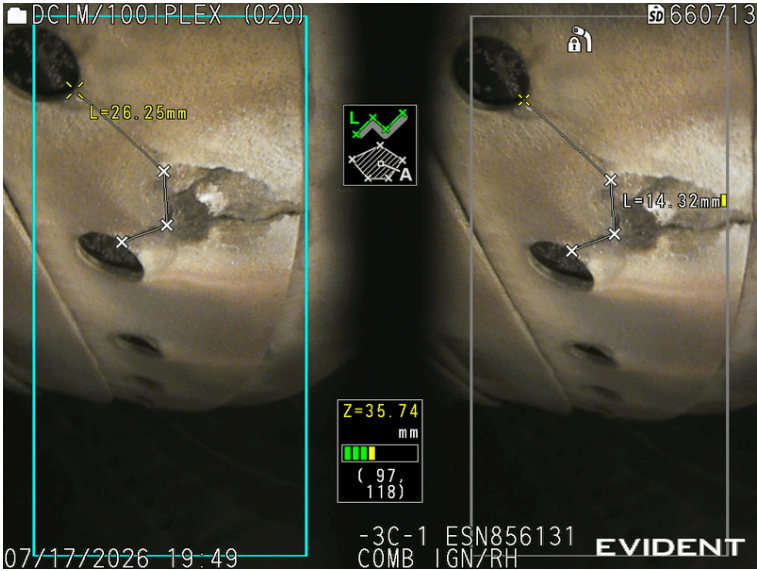
CC  
Combustion  
Chamber

Rejected

CRACKED

4 Axial crack can turn to  
circumferential crack for a  
short distance ( LES THAN  
ONE DILUTION LAND IN  
LENGT)  
OUT OFF LIMITS  
IAW AMM

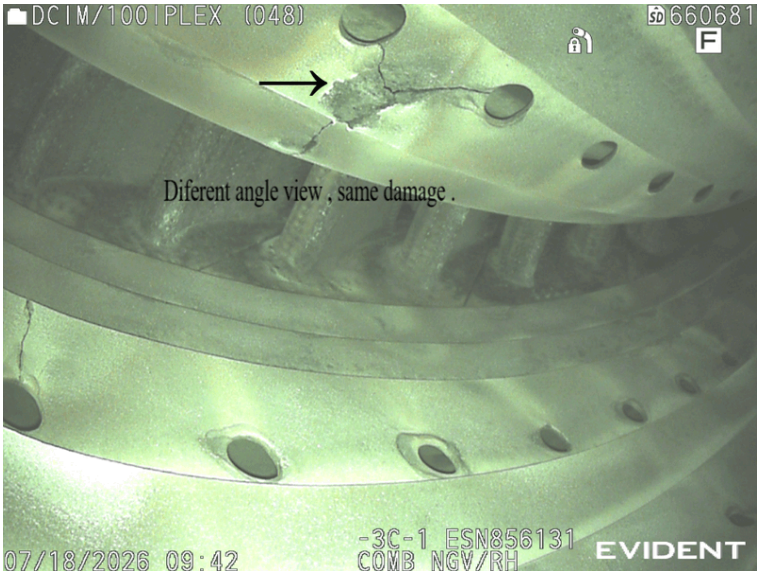
Rejected

Diferent angle view , same damage :

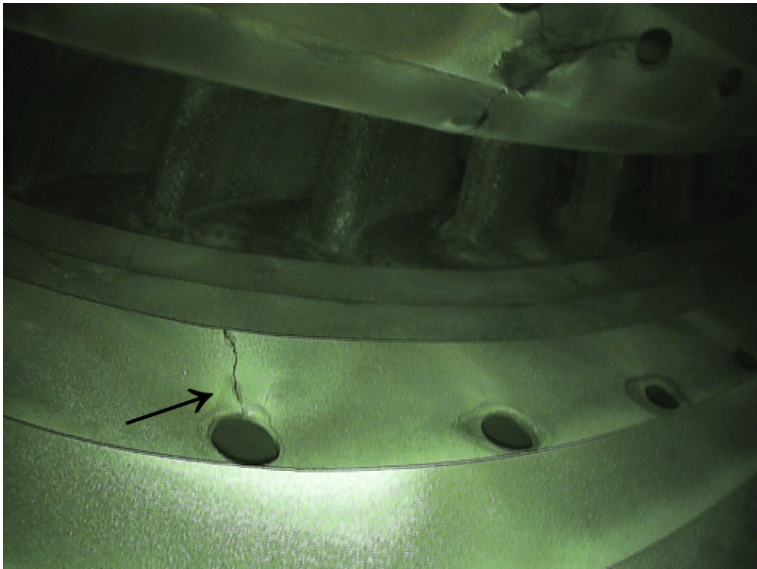
Axial cracks on the Outer Liner :

Axial cracks that go across 1 panel or less are permitted IAW AMM 72-00-00216-022-C00

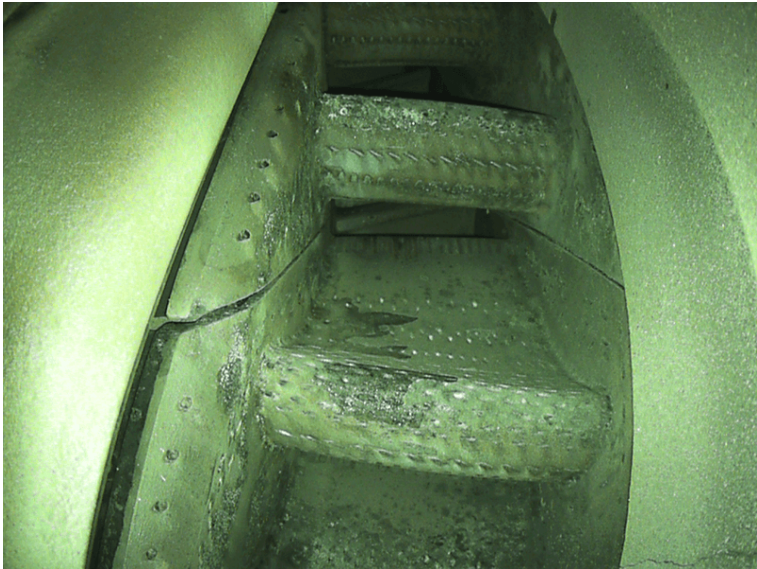
HPT  
Nozzle Guide  
Vane

1 NO DAMAGE FOUND :  
No Cracks , no burns , no  
missing material , no  
deformation on cooling holes  
. concave and convex sides

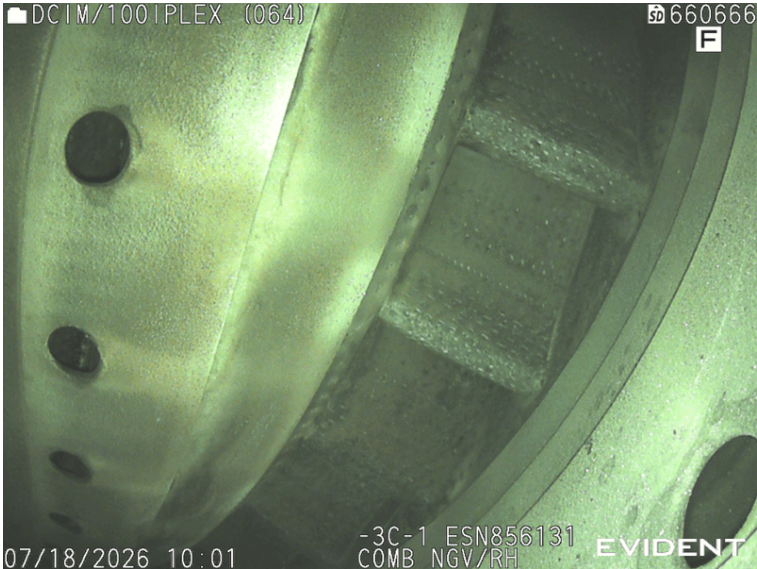
HPT  
Nozzle Guide  
Vane

1 NO DAMAGE FOUND ON  
NGV .

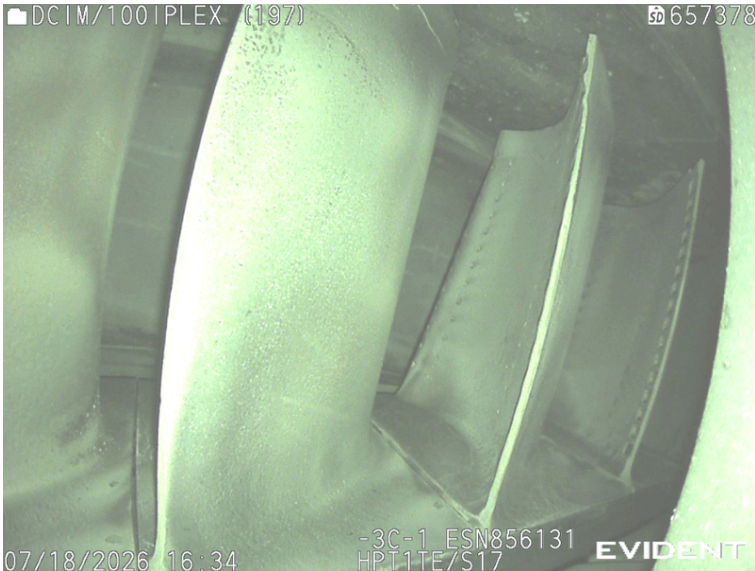
HPT  
Stage 01  
LeadingEdge

NO DAMAGE FOUND ON  
T1 HPT

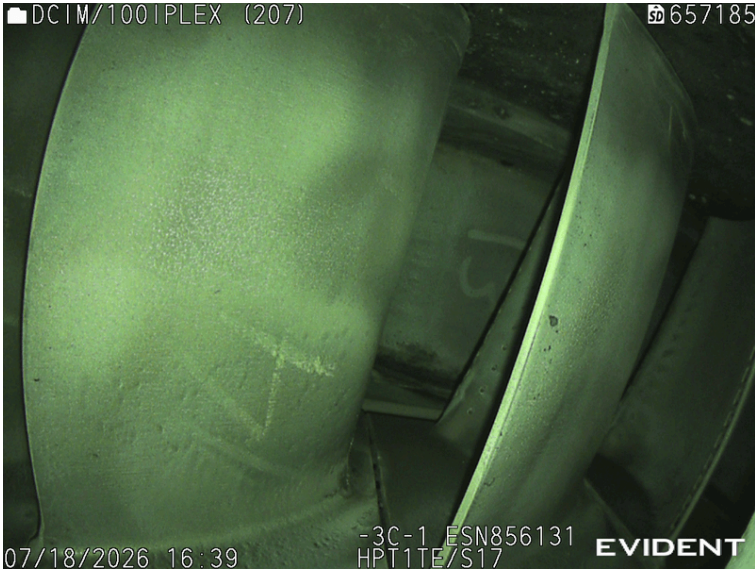
HPT  
Stage 01  
TrailingEdge

NO DAMAGE FOUND ON  
HPT 1

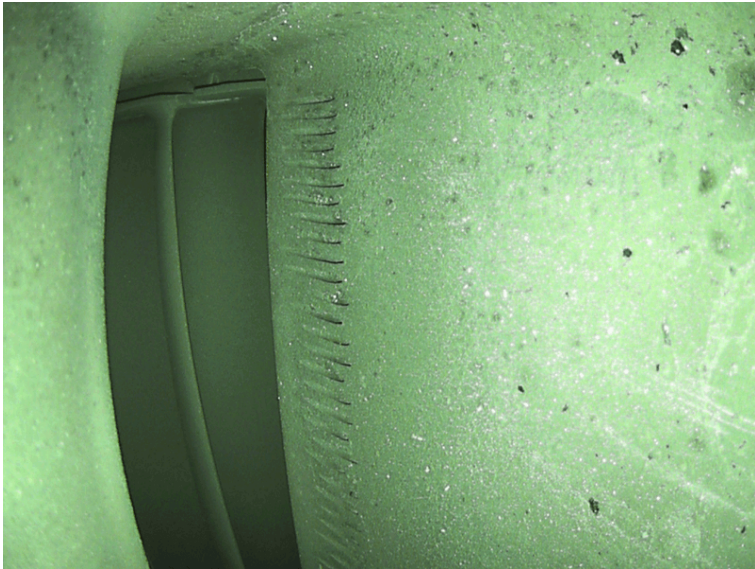
LPT  
Stage 01  
LeadingEdge

Accepted  
-3C-1 ESN856131LPT1/S18  
NO DAMAGE FOUND .  
(upper half blade view )

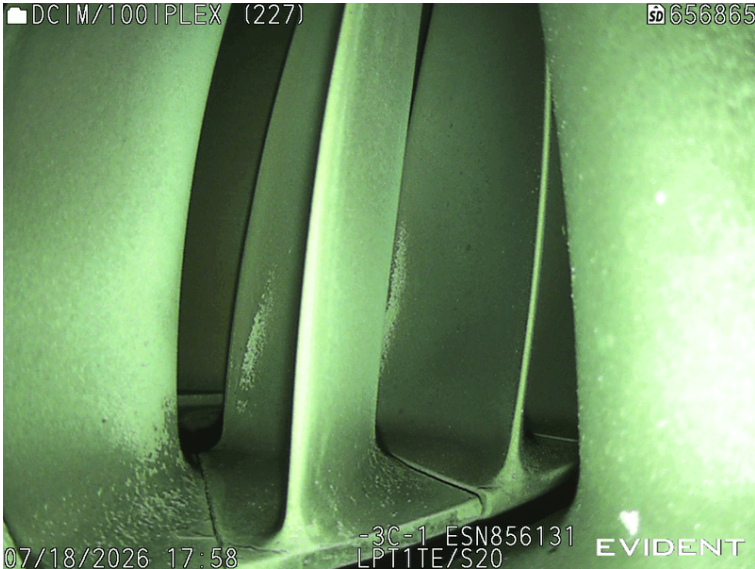
LPT  
Stage 01  
TrailingEdge

Accepted  
-3C-1  
ESN856131LPT1TE/S20  
NO DAMAGE FOUND  
( lower half blade view )  
Dust , Observed

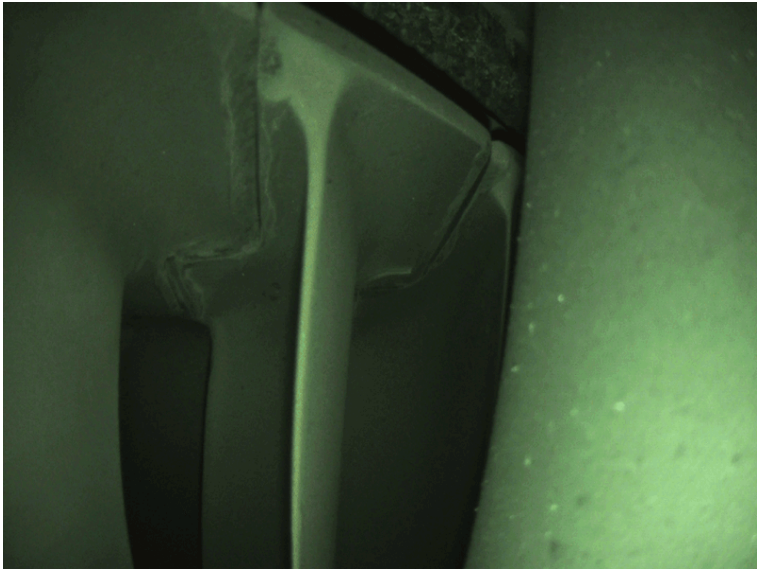
LPT  
Stage 01  
TrailingEdge

NO DAMAGE FOUND

(lower half blade view )

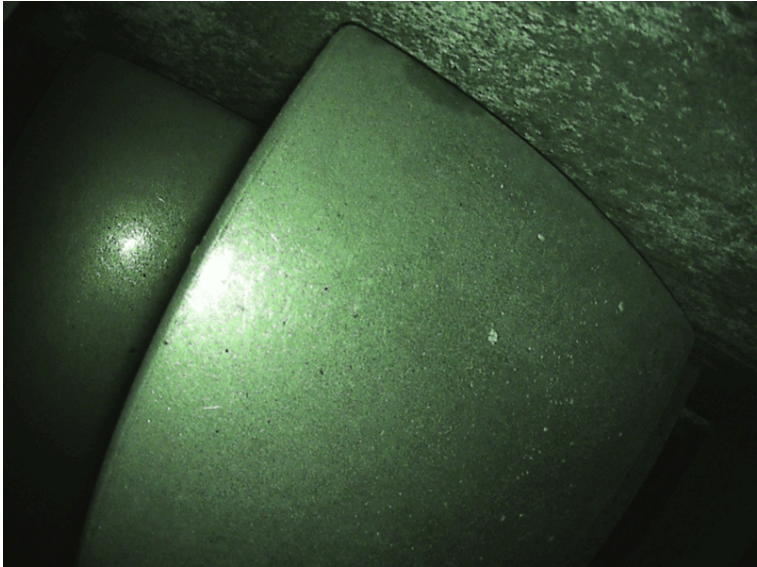
LPT  
Stage 02  
LeadingEdge

NO DAMAGE FOUND

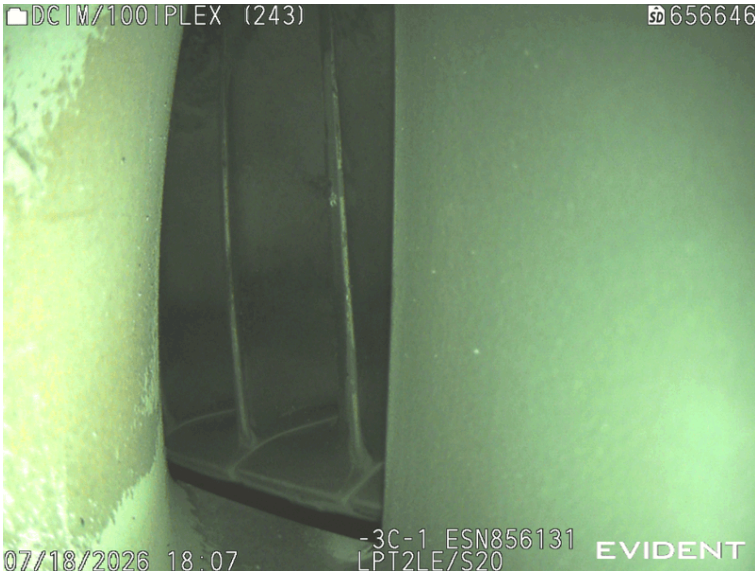
LPT  
Stage 02  
LeadingEdge

Accepted  
-3C-1  
ESN856131LPT2LE/S20  
NO DAMAGE FOUND  
( lower half blade view )

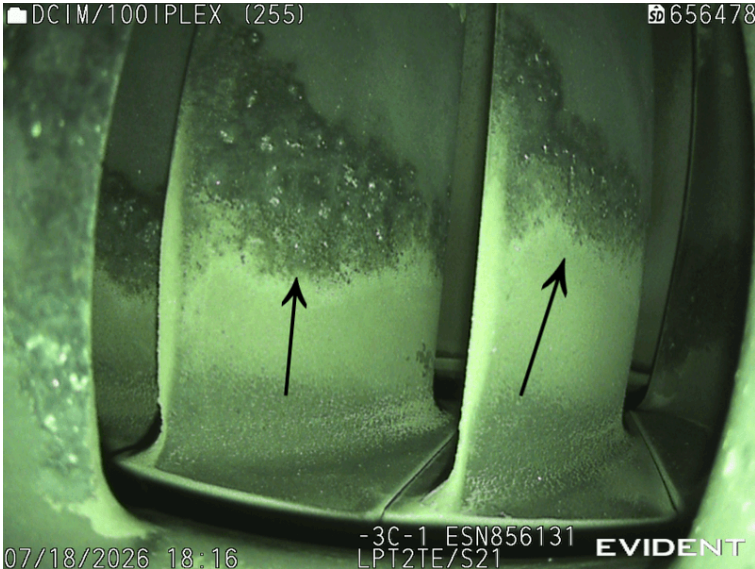
LPT  
Stage 02  
TrailingEdge

Accepted  
-3C-1  
ESN856131LPT2TE/S21  
NO DAMAGE FOUND  
Dust and Hi amount of  
Moisture observed .  
( lower half blade view )

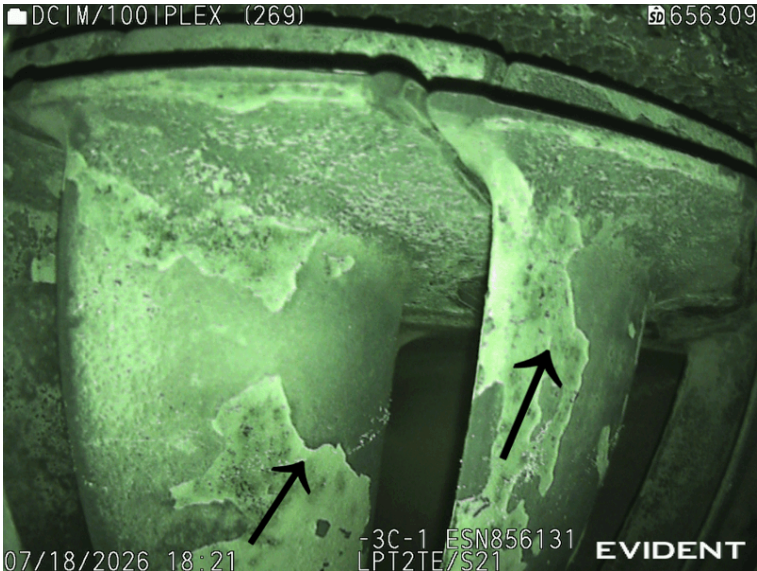
LPT  
Stage 02  
TrailingEdge

Review Minor

2 FOUND COATING PROTECTION MISSING AND PITTING ON THE BLADES ROOTS

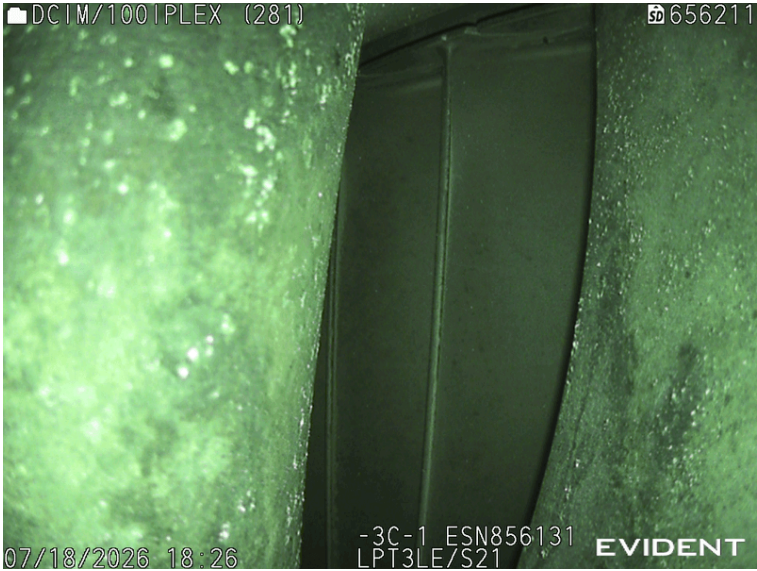
LPT  
Stage 03  
LeadingEdge

1 NO DAMAGE FOUND ( upper part blade view )

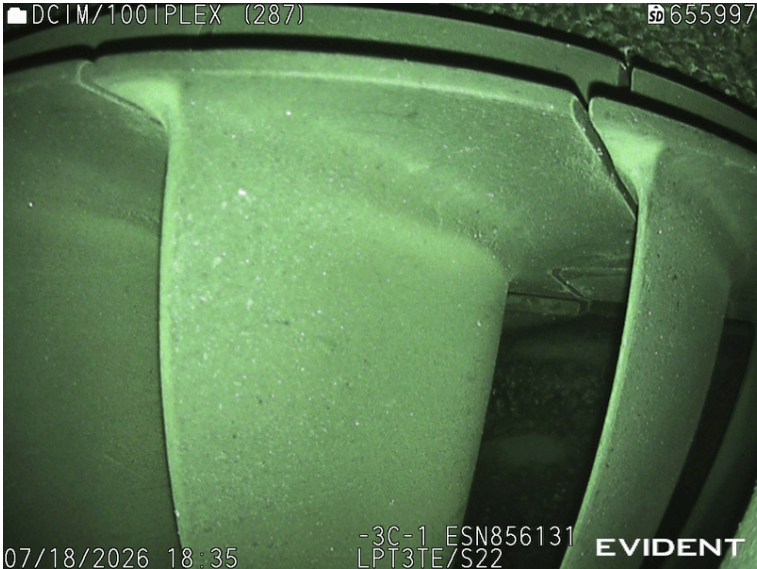
LPT  
Stage 03  
TrailingEdge

Accepted  
-3C-1  
ESN856131LPT3TE/S22  
NO DAMAGE FOUND
