# **NON PERFORMANCE BOREScope INSPECTION**

## **CM56-3 C1 ESN856136**

Performed : Jul 27 2026

CFM56-3C1

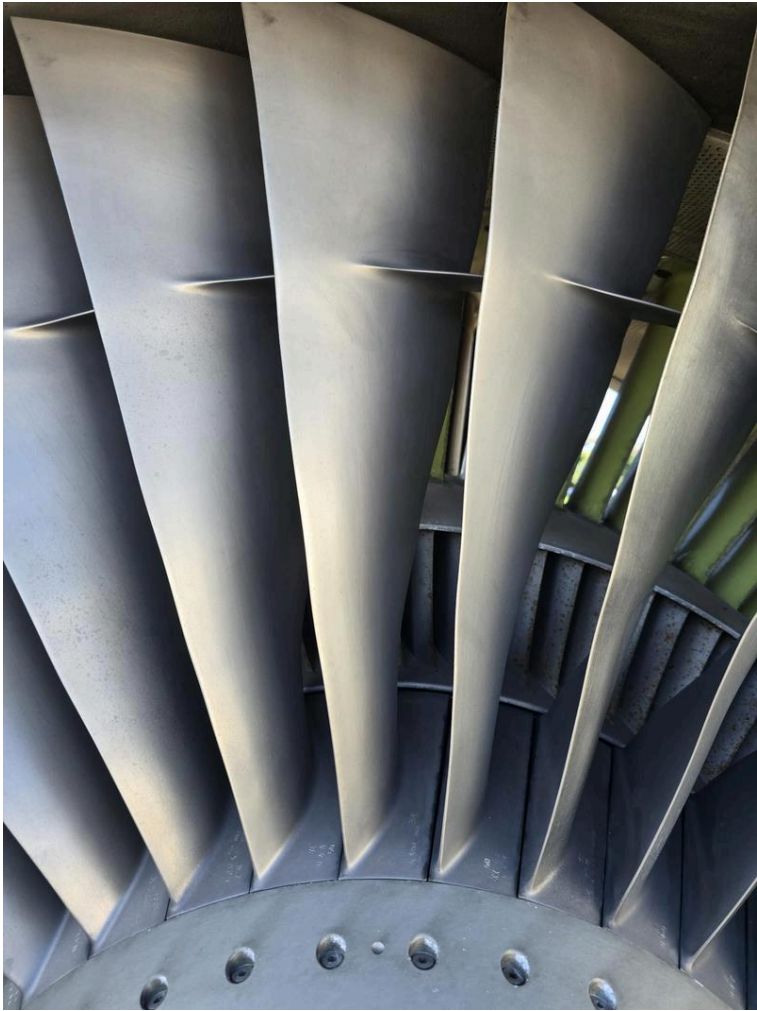
FAN BLADES LE

Accepted

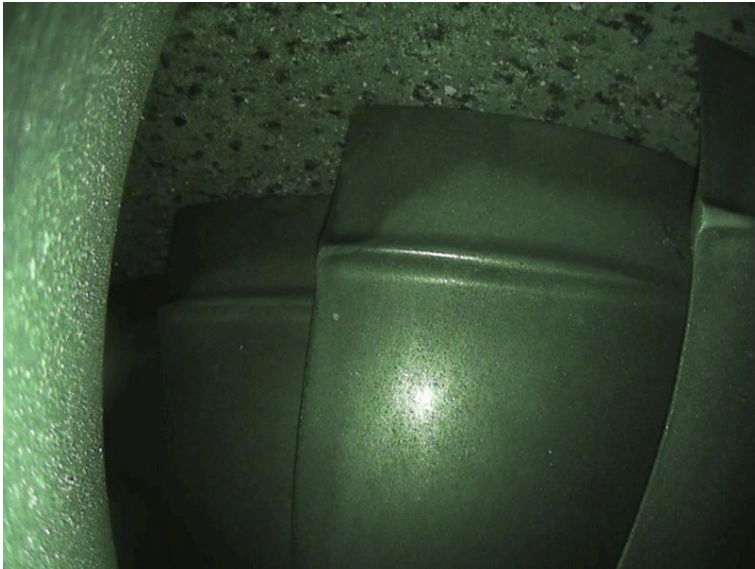
| Location | | Results/Comments |
|---|---|---|
| HPC<br>Stage 01<br>LeadingEdge | | Accepted<br>3C-1 SN856136 HPT1LE/S1<br>1<br>No damage found |

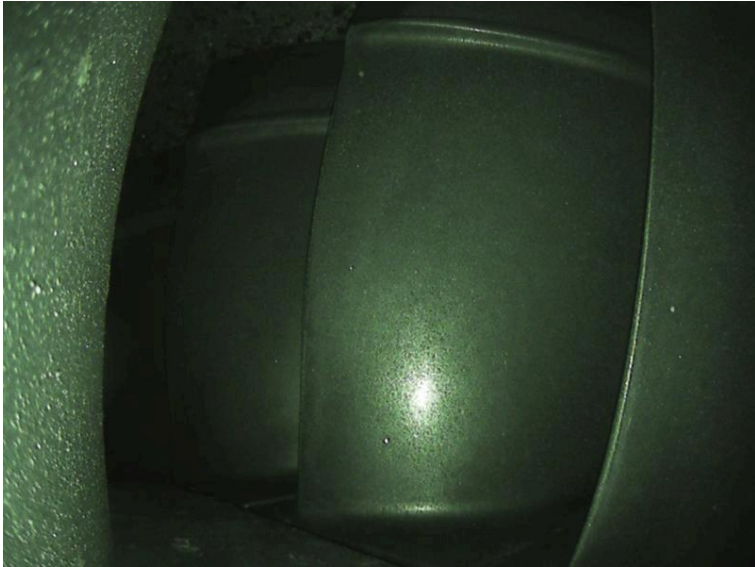
| Location | | Results/Comments |
|---|---|---|
| HPC<br>Stage 01<br>LeadingEdge | | Accepted<br>3C-1 SN856136 HPT1LE/S1<br>1<br>No damage found |

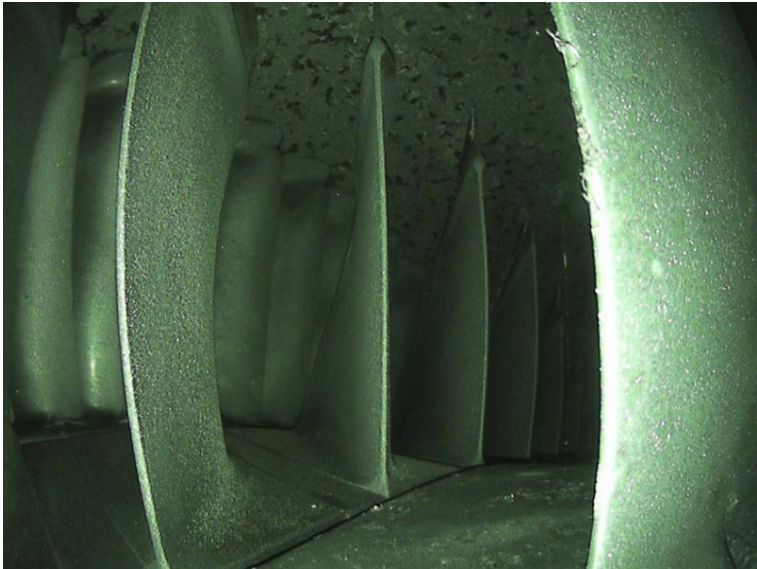
HPC  
Stage 01  
TrailingEdge

Accepted  
3C-1 SN856136 HPT1LE/S1  
1 No damage found , an engine wash its recommended

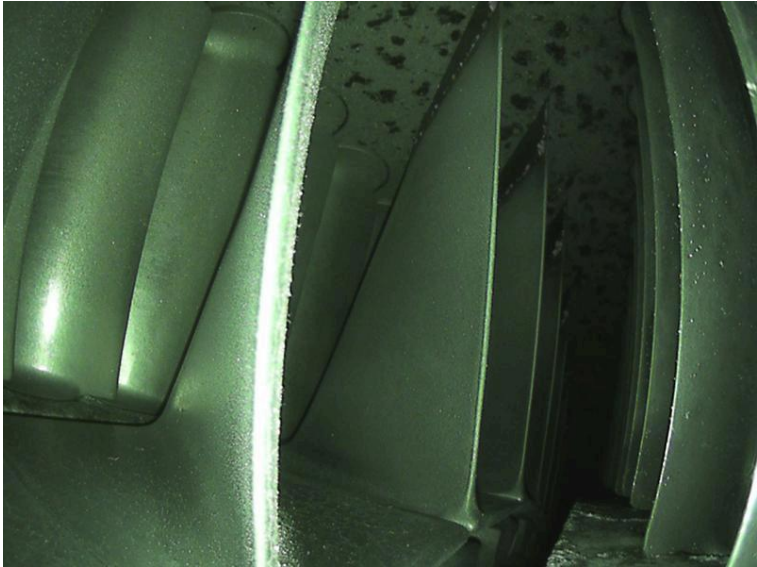
HPC  
Stage 02  
LeadingEdge

Accepted  
3C-1 SN856136 HPT2LE/S2  
1 No damage found

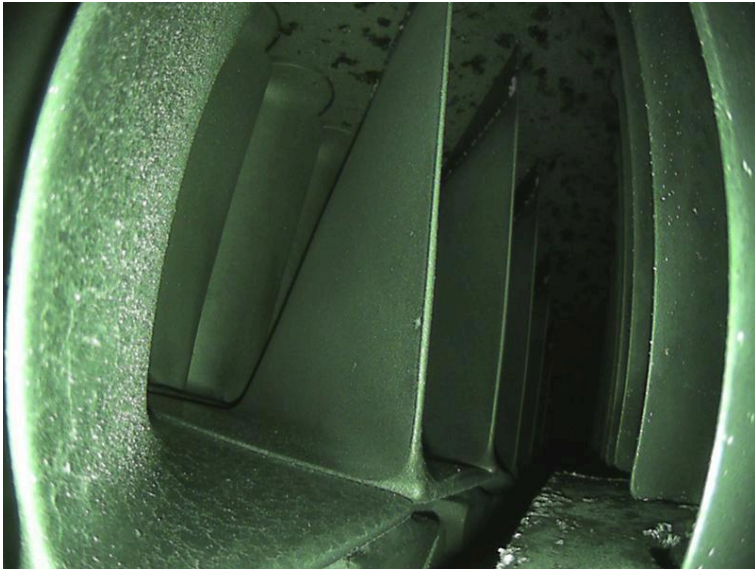
| Location | | Results/Comments |
|---|---|---|
| HPC<br><br>Stage 02<br>LeadingEdge | | <div>Accepted</div> <div>3C-1 SN856136 HPT2LE/S2</div> <div>1 No damage found , An engine wash is recommended</div> |

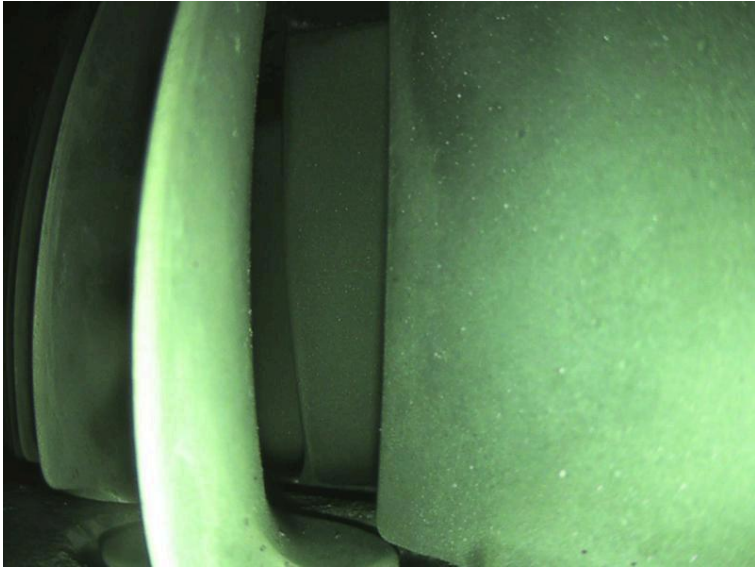
| Location | | Results/Comments |
|---|---|---|
| HPC<br><br>Stage 02<br>TrailingEdge | | <div>Accepted</div> <div>3C-1 SN856136 HPT2TE/S3</div> <div>1 No damage found</div> |

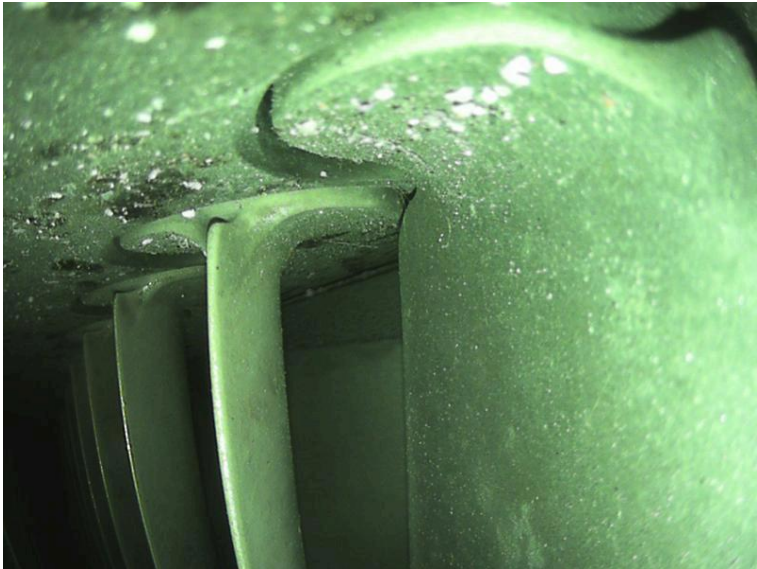
HPC  
Stage 02  
TrailingEdge

Accepted  
3C-1 SN856136  
HPT2TE/S3  
1 No damage found , an engine wash is recommended. Dust and moisture observed

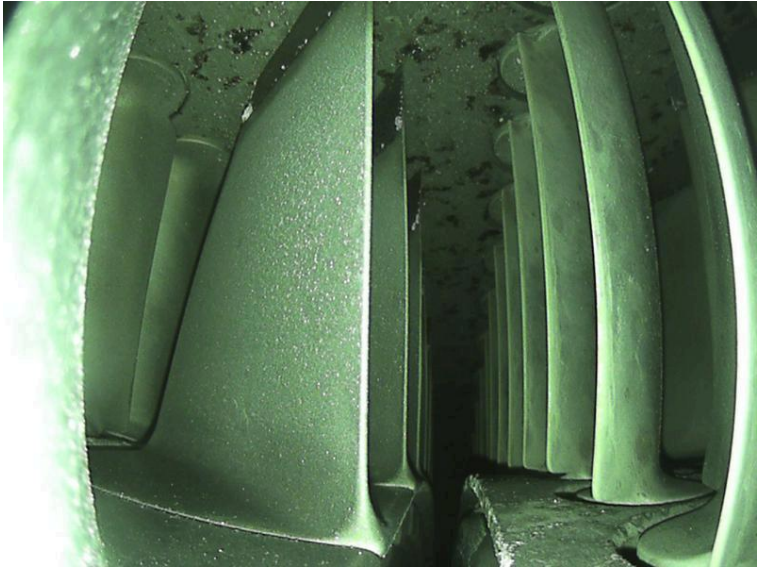
HPC  
Stage 03  
LeadingEdge

Accepted  
3C-1 SN856136  
HPT2LE3/S3  
1 No damage found

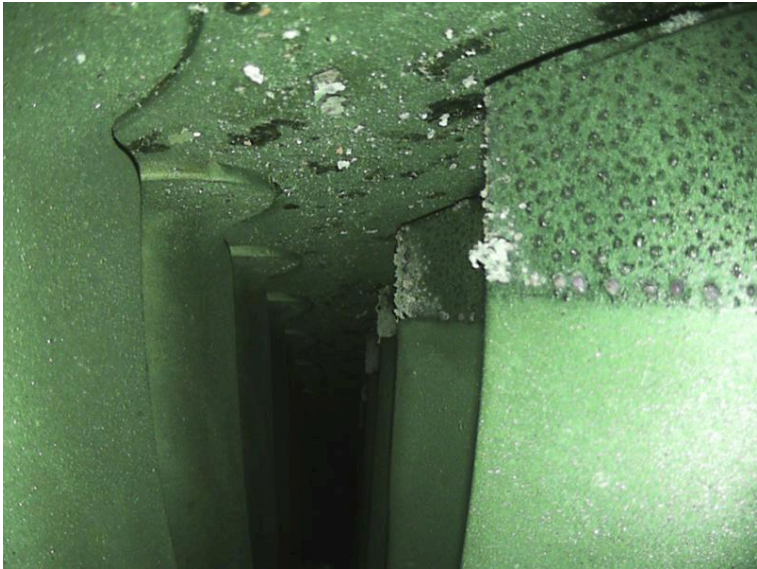
Stage 03  
TrailingEdge

Accepted

No damage found , formation  
due to moisture  
accumulation

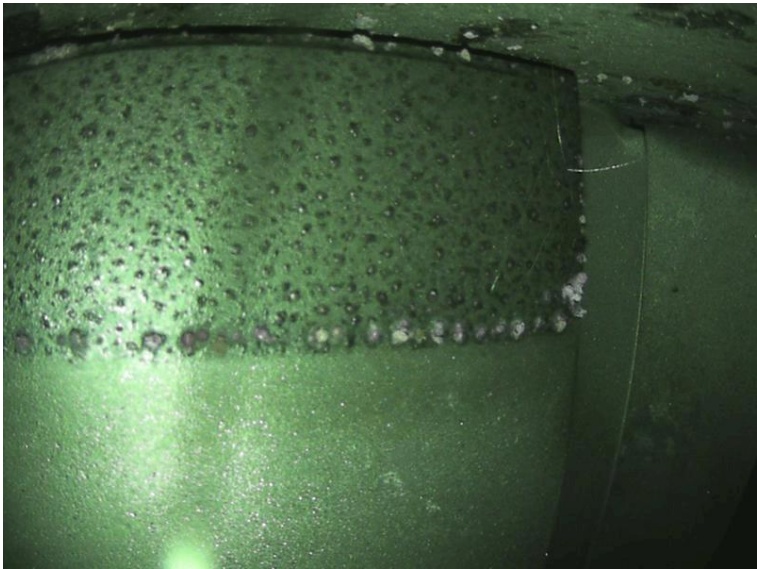
Stage 03  
TrailingEdge

Accepted

No damage found , formation  
due to moisture  
accumulation

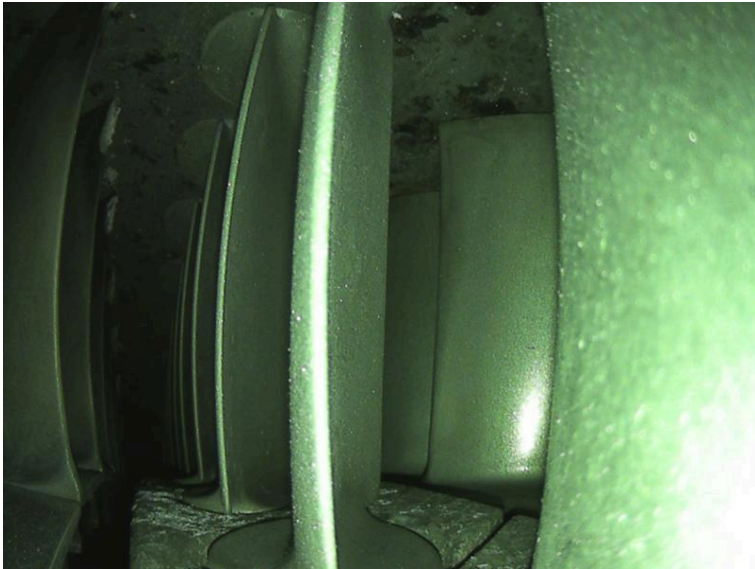
| Location | | Results/Comments |
|---|---|---|
| HPC<br><br>Stage 04<br>LeadingEdge | | <div>Accepted</div> <div>3C-1 SN856136 HPT4LE/S4</div> <div>1</div> <div>No damage found .</div> |

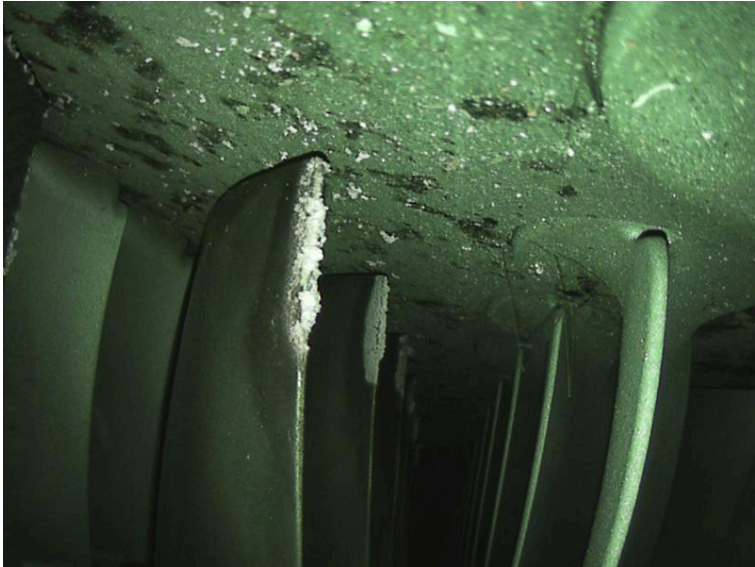
| Location | | Results/Comments |
|---|---|---|
| HPC<br><br>Stage 04<br>LeadingEdge | | <div>Accepted</div> <div>3C-1 SN856136 HPT4LE/S4</div> <div>1</div> <div>No damage found , dust and moisture observed</div> |

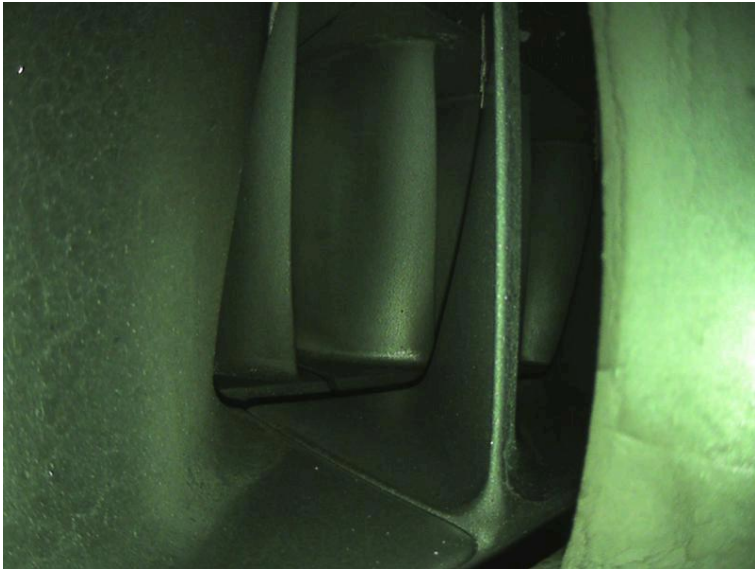
| Location | | Results/Comments |
|---|---|---|
| HPC<br><br>Stage 05<br>LeadingEdge | | Accepted<br><br>3C-1 SN856136 HPT5LE/S5<br>1 No damage found |

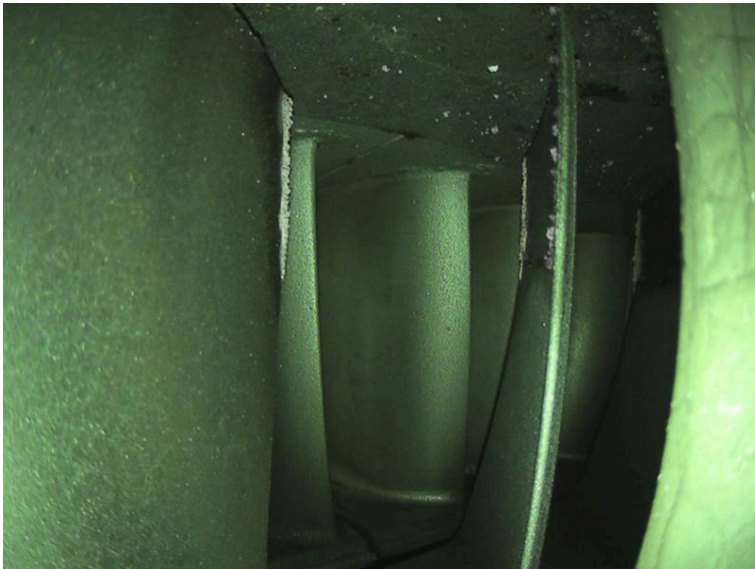
| Location | | Results/Comments |
|---|---|---|
| | | Accepted<br><br>3C-1 SN856136 HPT5LE/S5<br>1 No damage found , dust and moisture |

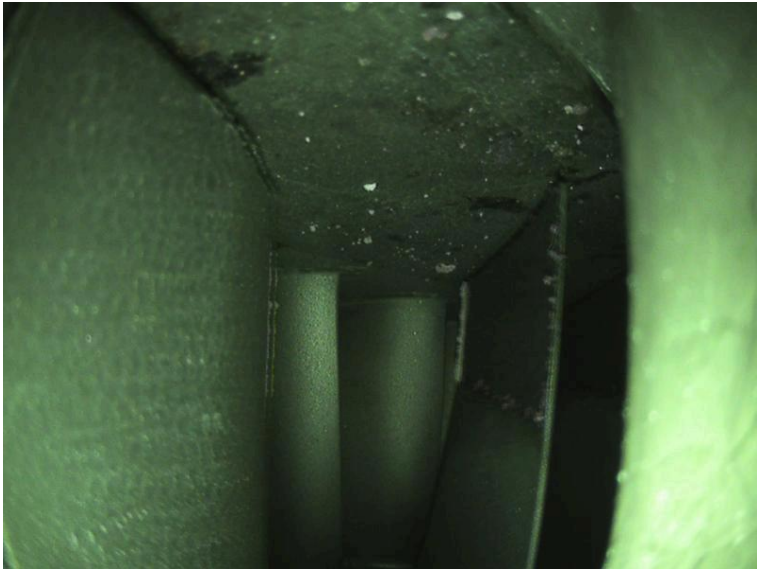
HPC  
Stage 05  
LeadingEdge

Accepted  
3C-1 SN856136 HPT5LE/S5  
1 No damage found , dust and moisture

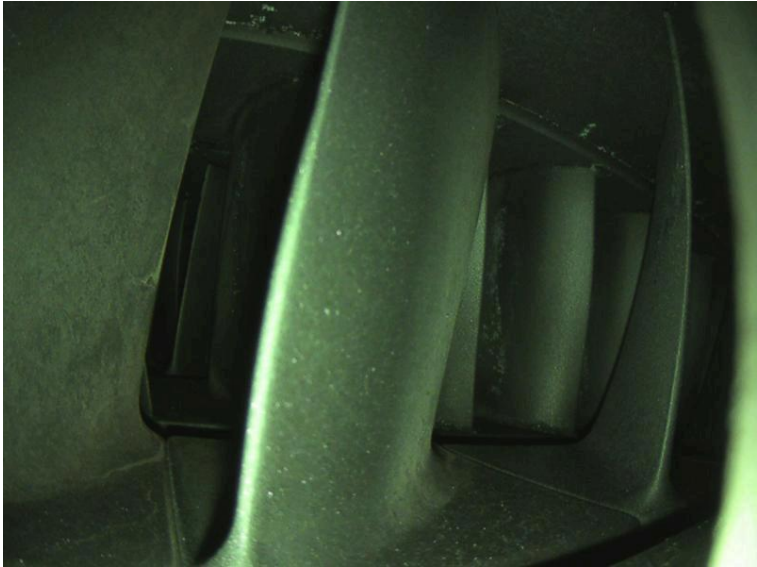
HPC  
Stage 05  
LeadingEdge

Accepted  
3C-1 SN856136 HPT6LE/S6  
1 No damage found .

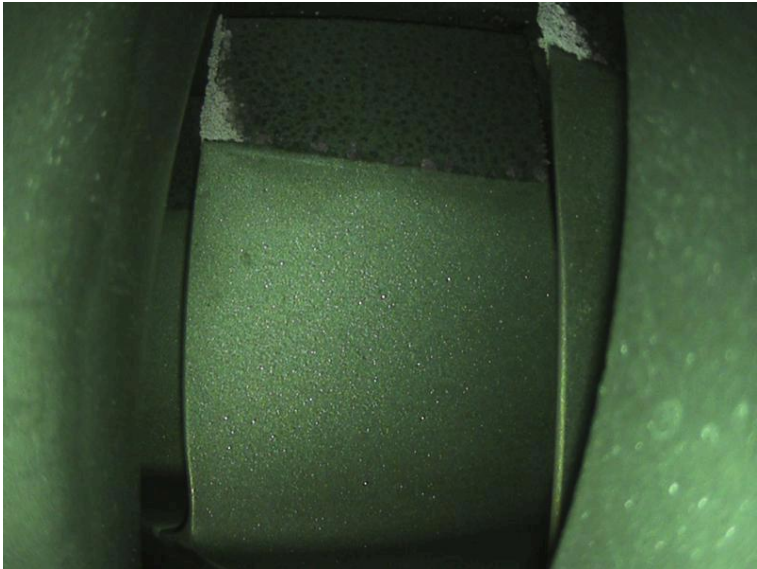
HPC  
Stage 05  
TrailingEdge

No damage found , dust and moisture observed

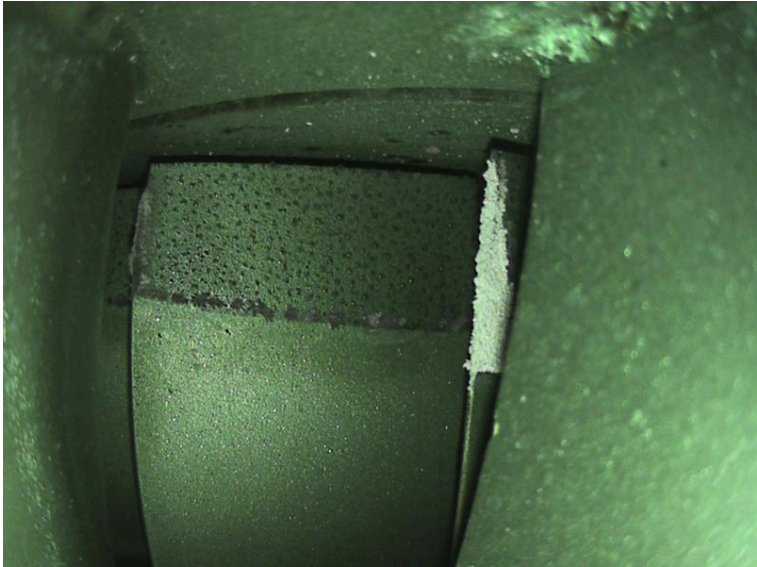
HPC  
Stage 05  
TrailingEdge

No damage found , dust and moisture observed .

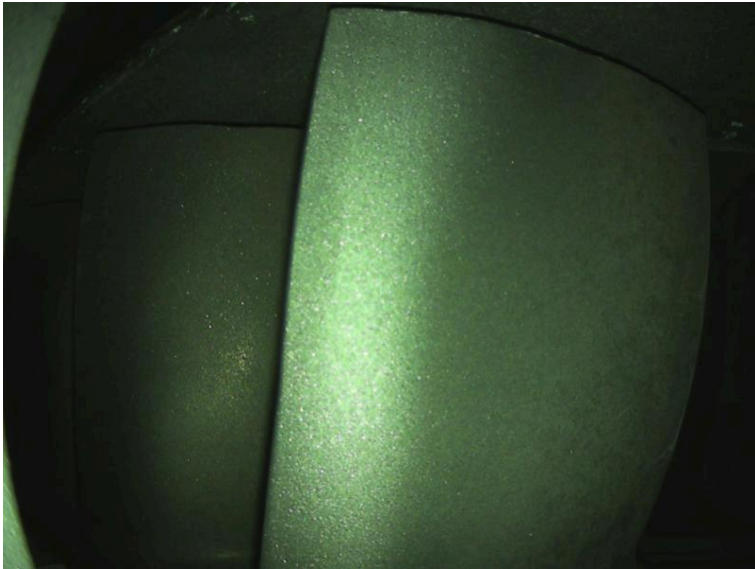
HPC  
Stage 06  
LeadingEdge

Accepted  
3C-1 SN856136 HPT6LE/S6  
1  
No damage found

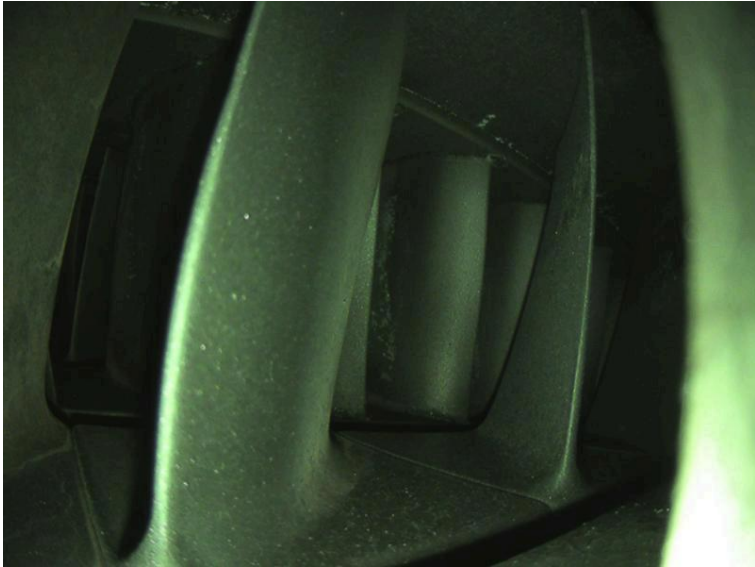
HPC  
Stage 06  
LeadingEdge

Accepted  
3C-1 SN856136 HPT6LE/S6  
1  
No damage found .

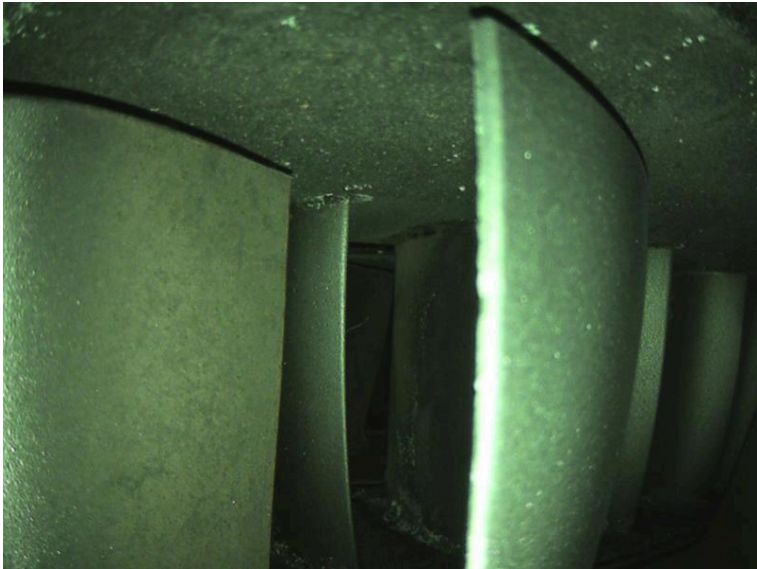
HPC  
Stage 07  
LeadingEdge

Accepted  
3C-1 SN856136 HPT7LE/S7  
1 No damage found

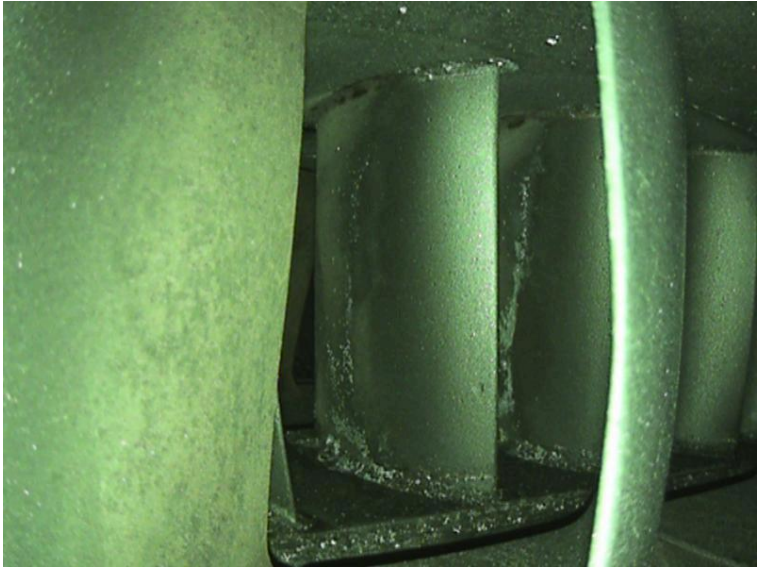
HPC  
Stage 07  
LeadingEdge

Accepted  
3C-1 SN856136 HPT7LE/S7  
1 No damage found , dust and moisture observed.

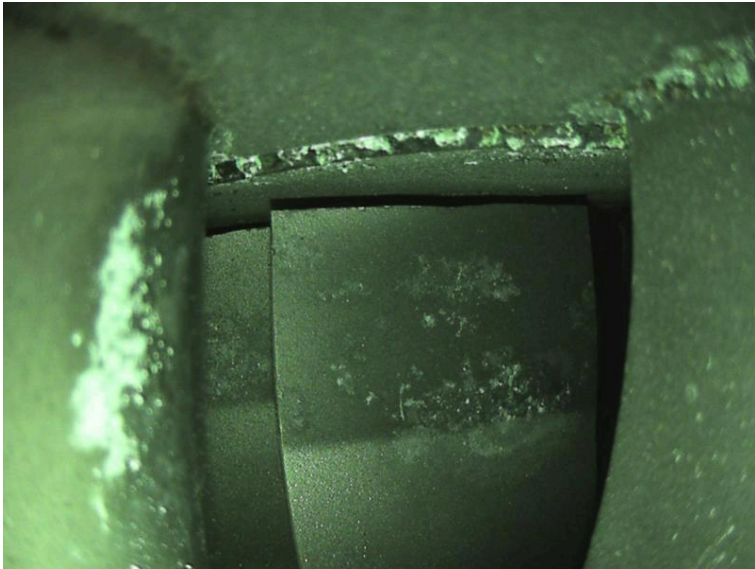
HPC  
Stage 07  
TrailingEdge

Accepted  
3C-1 SN856136  
HPT6TE/S7  
1  
No damage found , dust and moisture observed

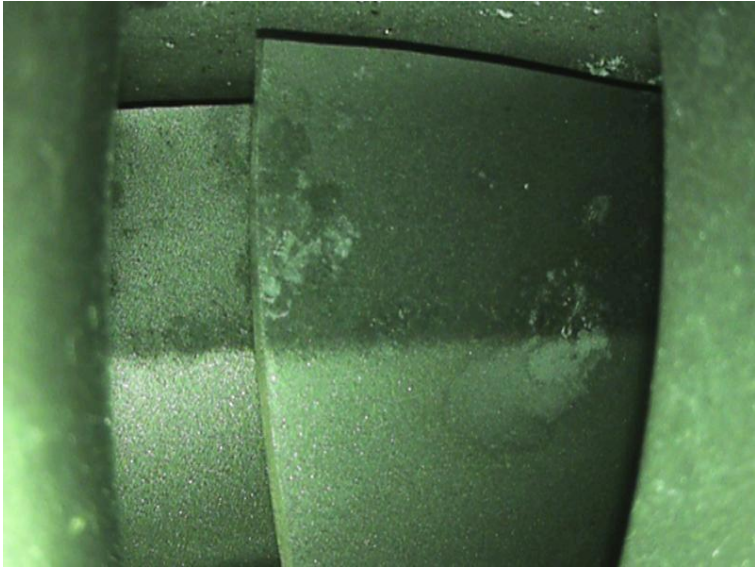
HPC  
Stage 07  
TrailingEdge

Accepted  
3C-1 SN856136  
HPT7TE/S8  
1  
No damage found , dust and moisture observed.

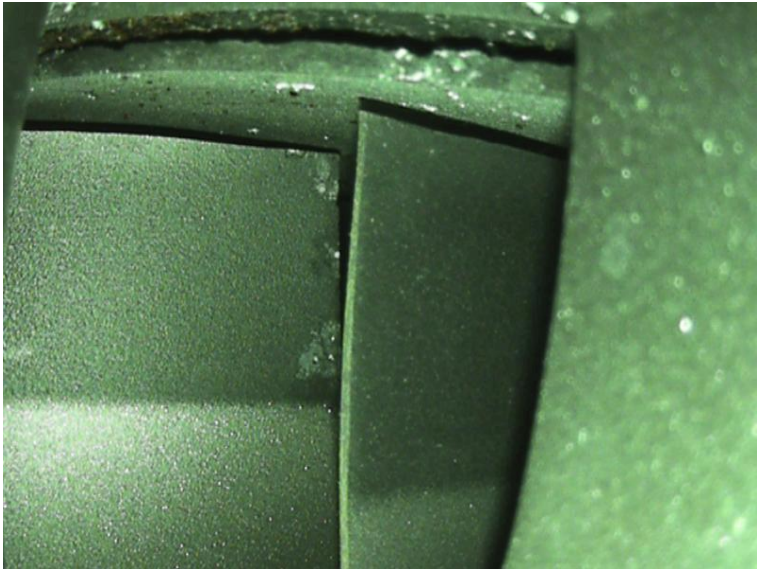
HPC  
Stage 07  
TrailingEdge

Accepted  
3C-1 SN856136  
HPT7TE/S8  
1 No damage found , dust and moisture observed .

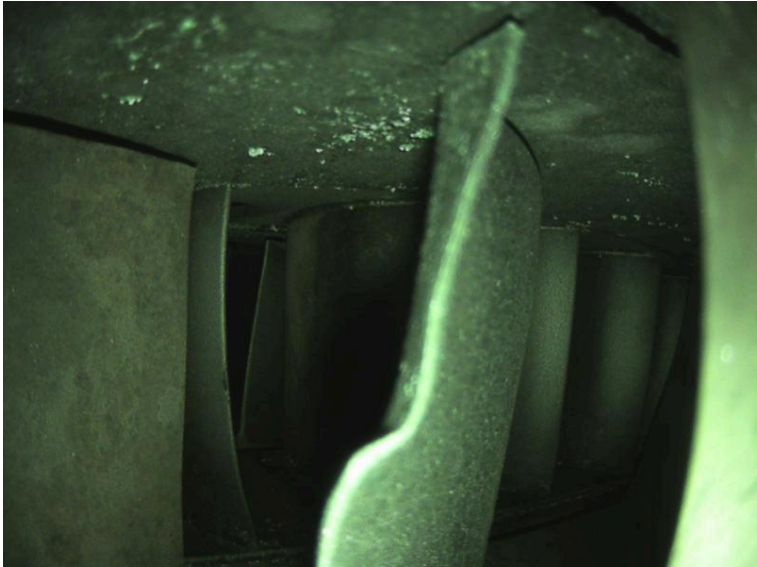
HPC  
Stage 08  
LeadingEdge

Review Minor  
DENTED  
2 Dent damage found on 8 Stg LE

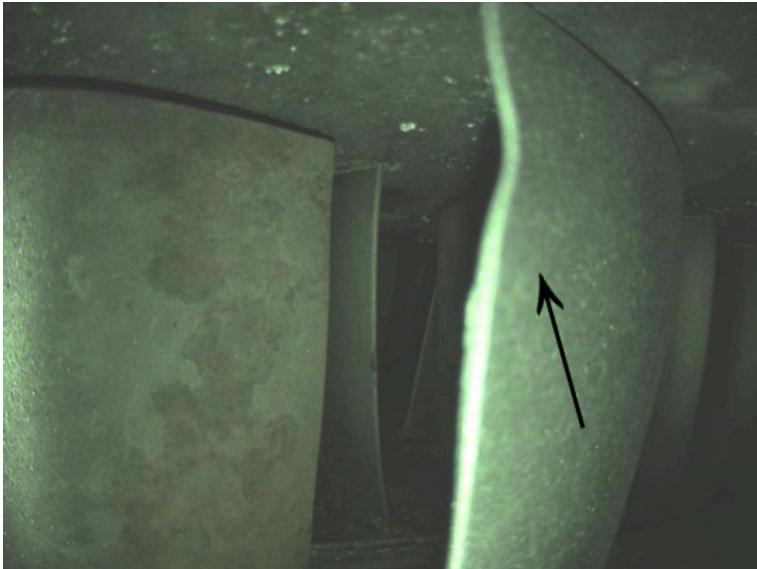
HPC  
Stage 08  
LeadingEdge

Accepted

DENTED

1 IAW MM 72-00-00-216-049  
Section I sub sect 1) No  
maximum number of dents if  
the damage is less than  
0.20 ( 3.8mm) in depth.

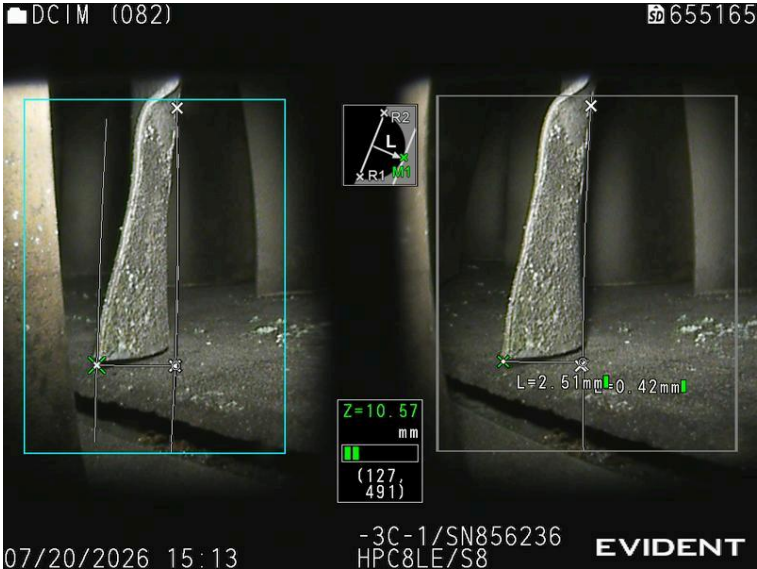
HPC  
Stage 08  
LeadingEdge

Review Minor

DENTED

2 IAW MM 72-00-00-216-049 ,  
No maximum number of  
dents if the damage is less  
than 0.15 inch ( 3.8mm) in  
depth.

Measurement 2.5mm in  
depth . In limits .  
Section I - Sub sect a)  
page 620

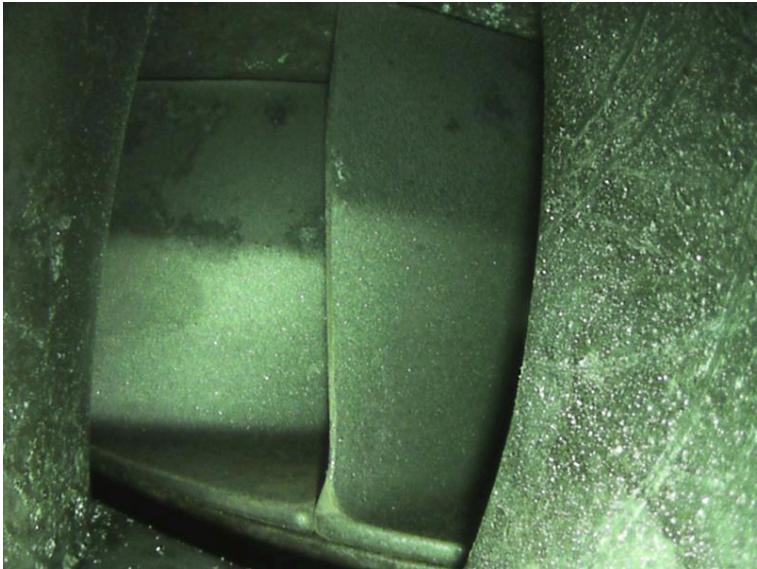
HPC  
Stage 08  
TrailingEdge

3C-1 SN856136  
HPT8TE/S9  
0  
No more damage found on 8  
Stg. blades TE .

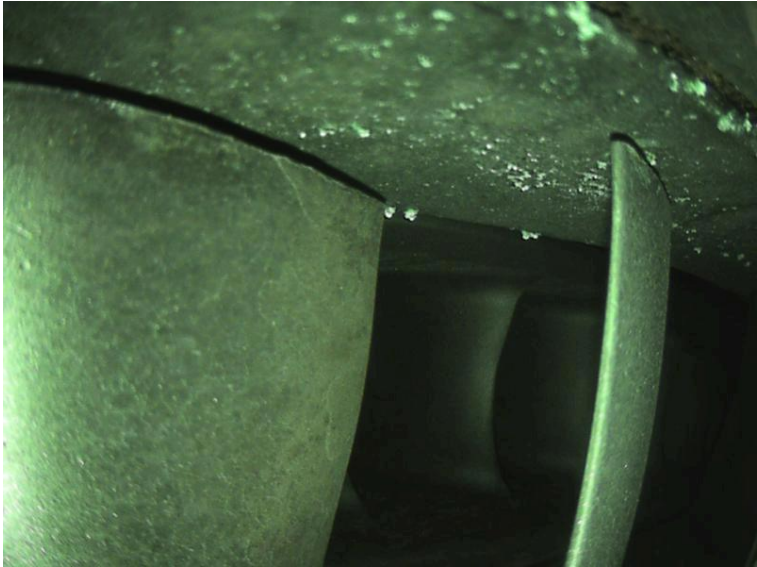
HPC  
Stage 09  
LeadingEdge

3C-1 SN856136 HPT9LE/S9  
1  
No damage found , dust and  
moisture observed .

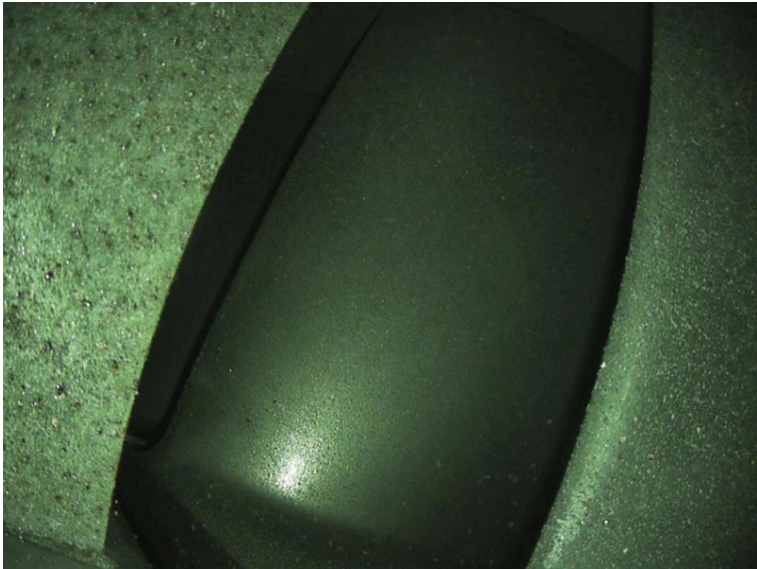
HPC  
Stage 09  
TrailingEdge

Accepted  
3C-1 SN856136 LPC4/S0  
No damage found.

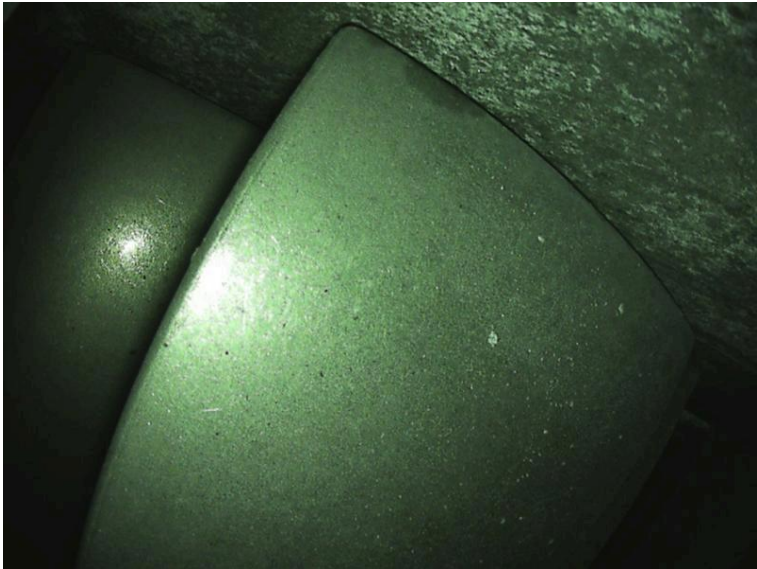
| Location | | Results/Comments |
|---|---|---|
| LPC<br>Stage 02<br>LeadingEdge | | Accepted<br>3C-1 SN856136 LPCLE<br>1<br>No damage found |

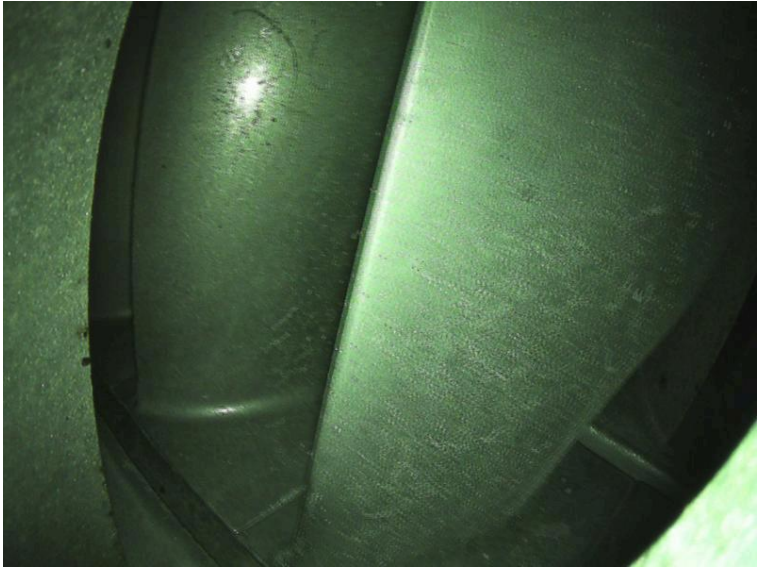
| Location | | Results/Comments |
|---|---|---|
| LPC<br>Stage 02<br>LeadingEdge | | Accepted<br>3C-1 SN856136 LPC2<br>1<br>No damage found |

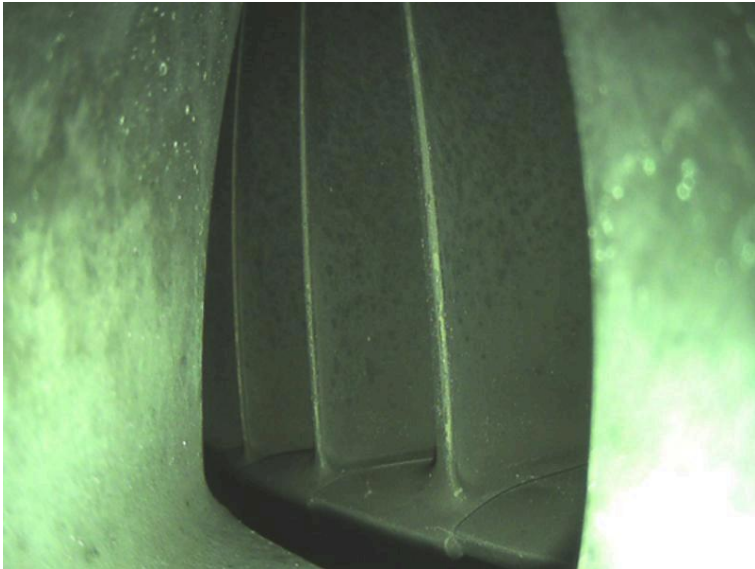
LPC  
Stage 02  
LeadingEdge

Accepted  
3C-1 SN856136 LPT2LE  
1 LPT2 LE No damage found .  
Dust and moisture observed

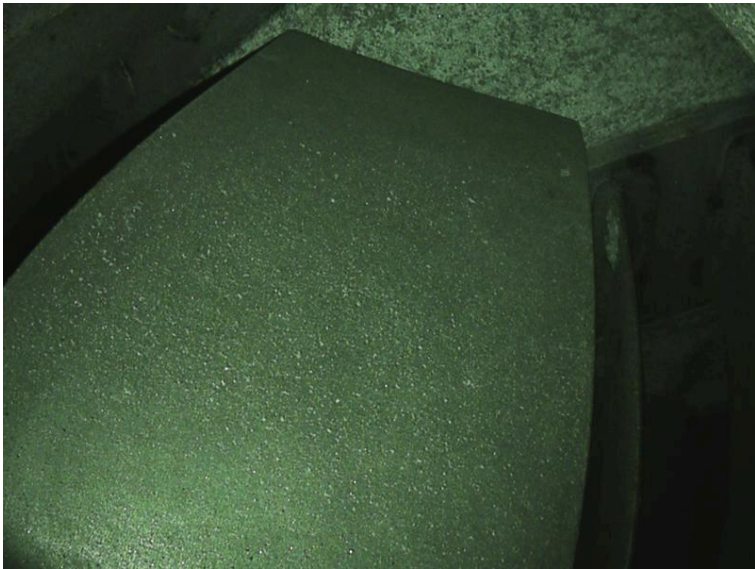
LPC  
Stage 03  
TrailingEdge

Accepted  
3C-1 SN856136 LPC3TE/S0  
1 No damage found

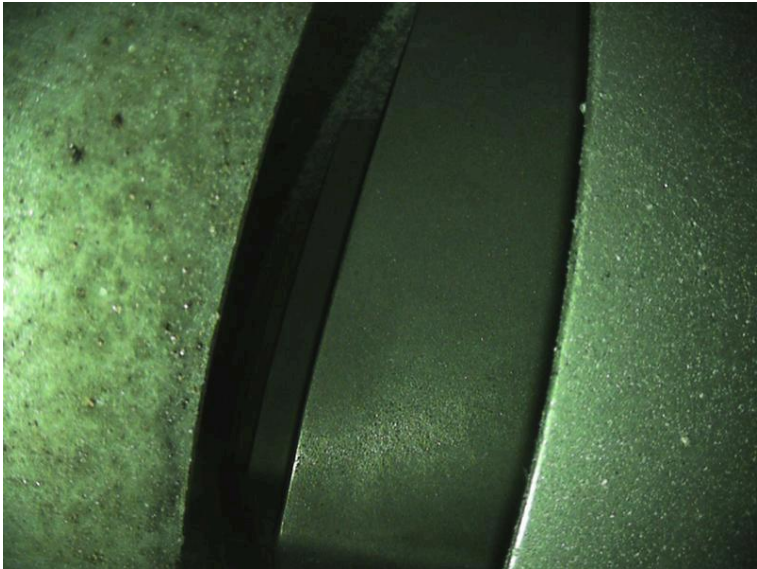
LPC  
Stage 03  
TrailingEdge

1 LPC 3 TE No damage found  
Dust and moisture observed

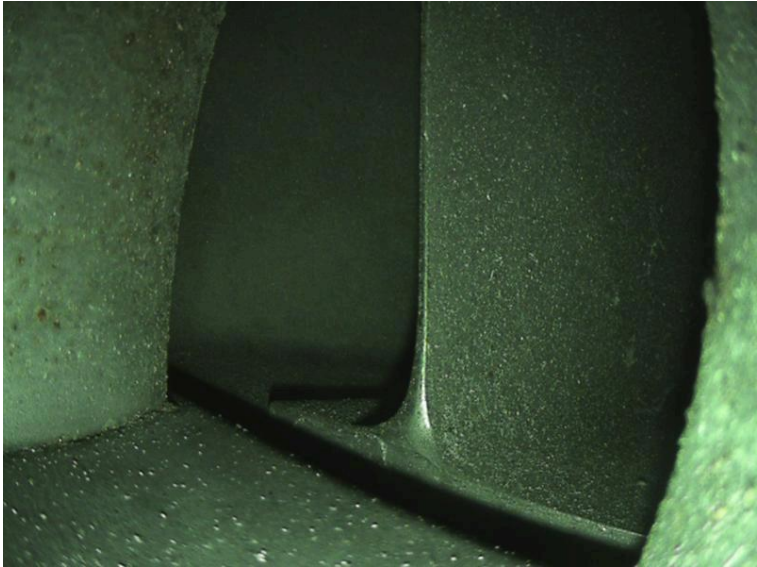
LPC  
Stage 03  
TrailingEdge

3C-1 SN856136 LPC3TE/S0  
1 LPC 3 TE No damage found .  
Dust and moisture observed.

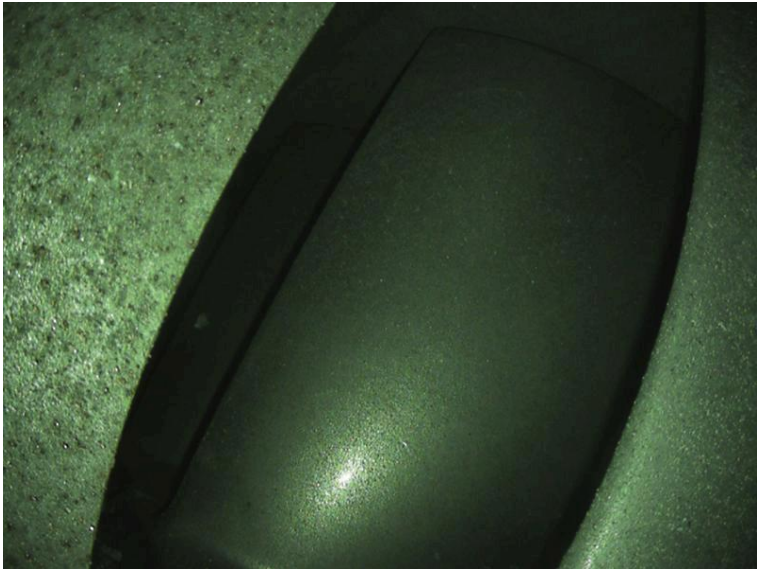
LPC  
Stage 04  
LeadingEdge

Accepted  
3C-1 SN856136 LPC4/S0  
1 No damage found

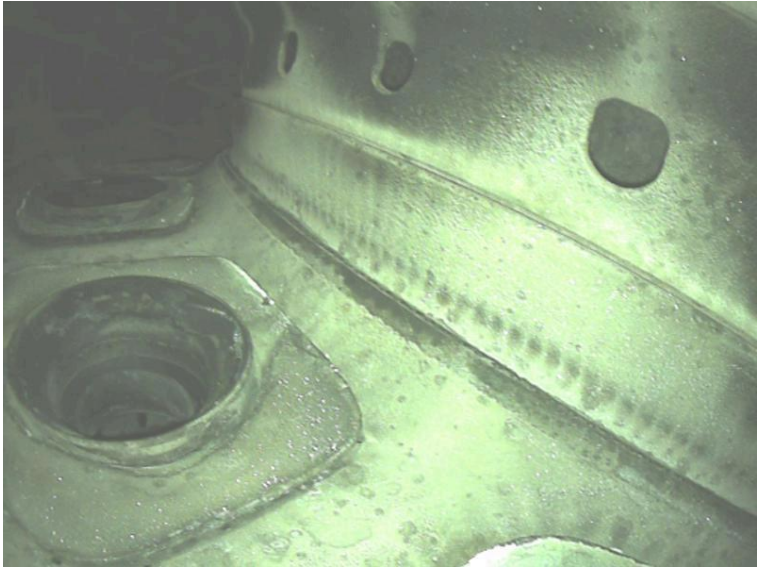
CC  
Combustion  
Chamber

Accepted  
3C-1 SN856136  
COMBUSTOR/NGV  
1 Dome band and panel 1 Ri1 /rib 2 no damage found all around

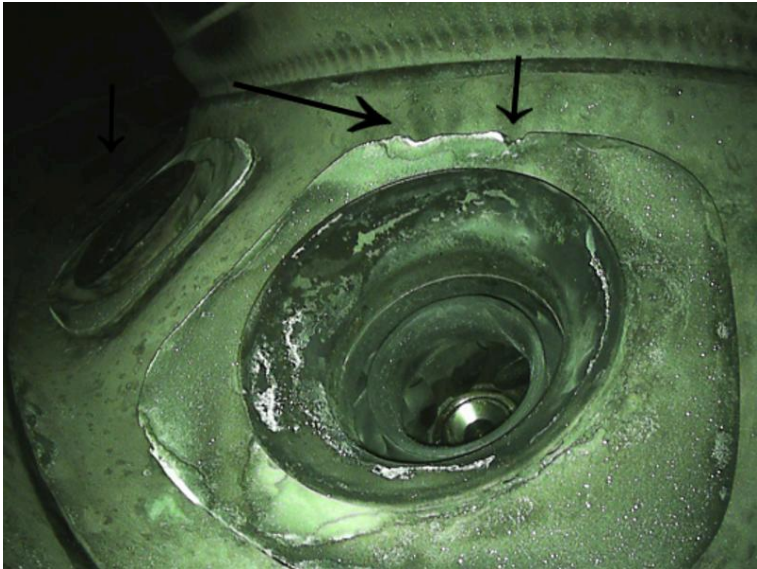
CC  
Combustion  
Chamber

| Location | Sub Location | Results/Comments |
|---|---|---|
| <a href="#">CC</a> | Combustion Chamber | <p>No damage found on HSI-COMBUSTION AREA / NGV<br/> No damage on Outer / Inner cases , dome band , panels , ribs .<br/> No damage on NGV no crack ,no burns no erosion .<br/> Slight burn on area 4 /1 on some deflector panels small radial craks " IN LIMITS "</p> |

Accepted  
BURNING  
Cuadrant 4/1 Deflector small  
burning IN LIMITS  
Cuadrant 4/1 Smll radial  
crack IN LIMITS

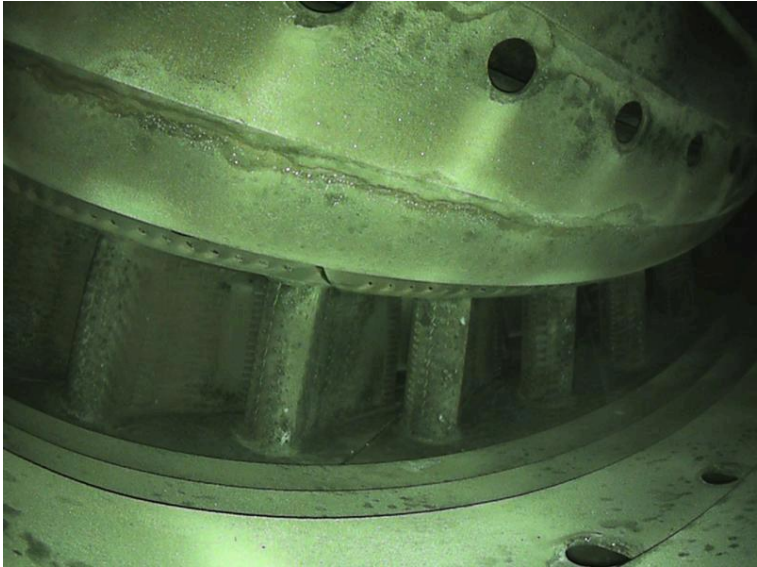
CC  
Combustion  
Chamber

Accepted  
3C-1 SN856136  
COMBUSTOR/NGV  
Outer panel 5/5 ,  
Inner panel 3 /4 no damage  
found all arround

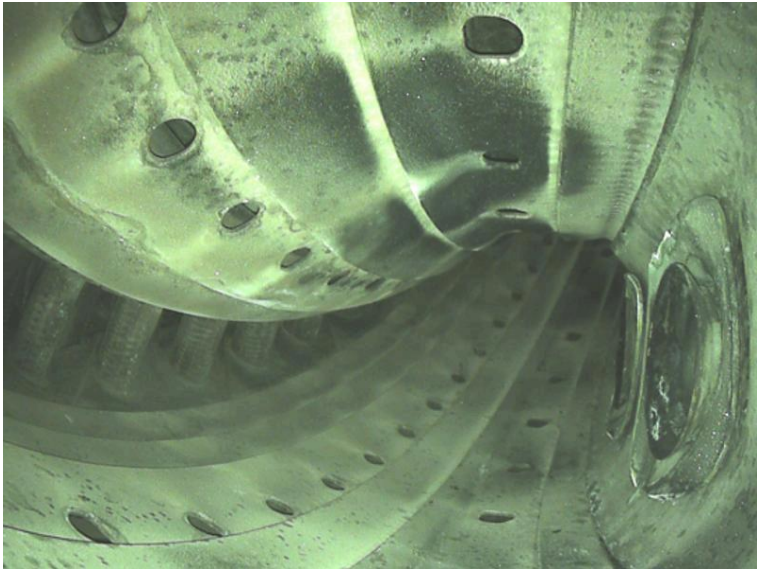
CC  
Combustion  
Chamber

1 Inner dome band , panels 2/3  
,  
Outer dome band panels  
1/2/3 no damage found all  
around

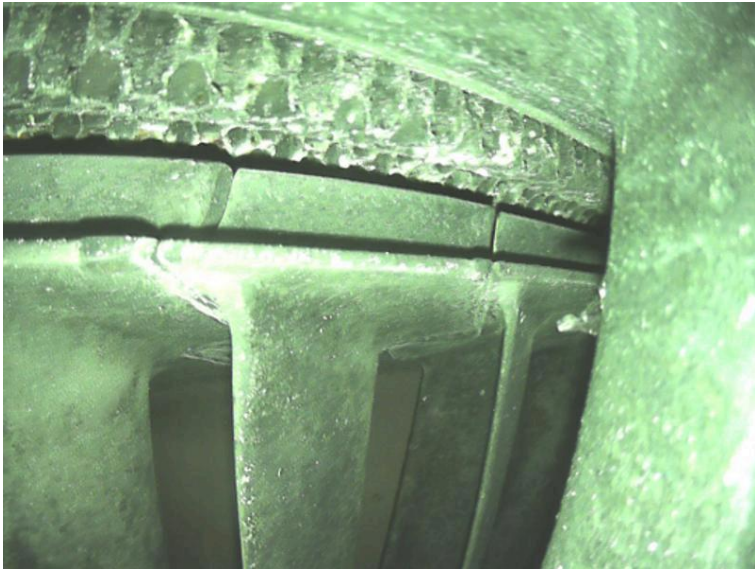
LPT  
Stage 01  
TrailingEdge

Accepted  
3C-1 SN856136 LPT1TE  
1 LPT 1 TE No damage found .  
Dust and moisture  
observed.

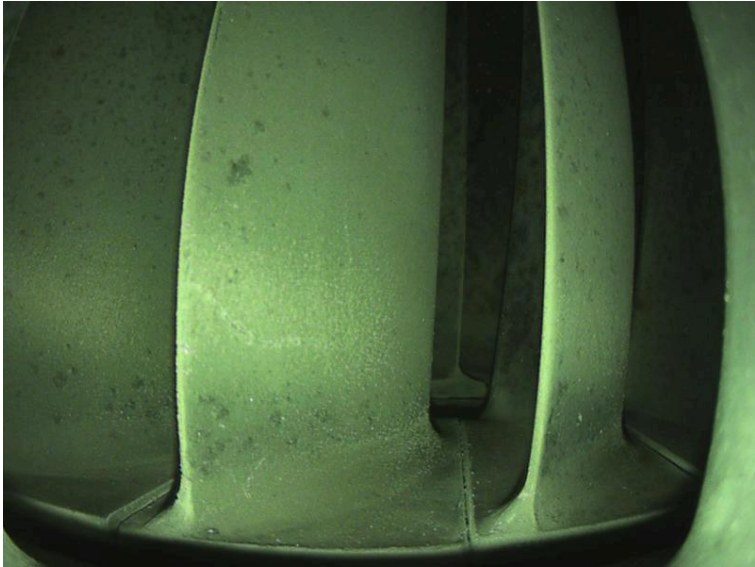
LPT  
Stage 03  
LeadingEdge

Accepted  
3C-1 SN856136 LPT3TE  
1 LPT3 LE , No damage  
found.

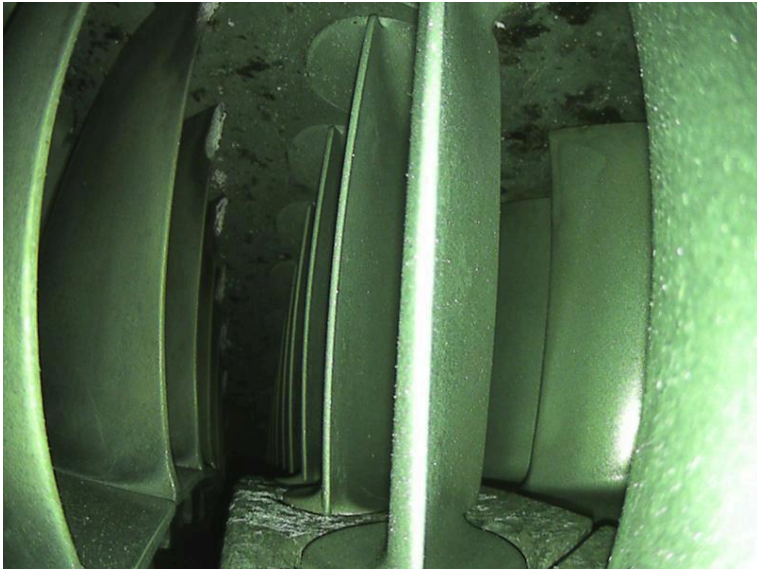
Rotor Blade  
LeadingEdge

Accepted  
3C-1 SN856136 HPT4LE/S4  
1 LPT 4 LE No damage found.

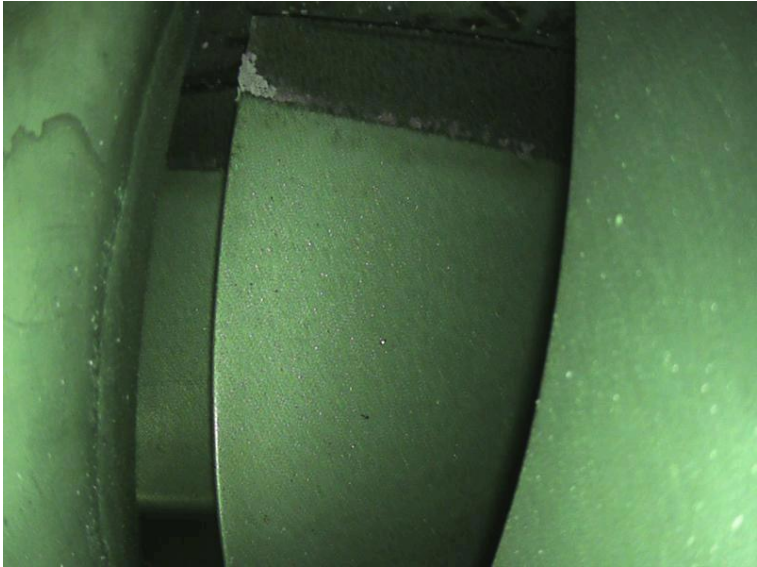
HPT Rotor balde  
4 TE  
TrailingEdge

Accepted  
3C-1 SN856136  
HPT4TE/S5  
1 HP4 TE, No damage found .  
Dust and moisture observed
