# **Non Performance Borescope Inspection Report**

Engine type: CF34-3A2

**Engine Serial 350350**  
**Customer :Fly All Ways**

Engine Type CF34-3A2  
Aircraft BOMBARDIER 601 Reg N545SD  
Engine S/N GE-E 350350  
Mark Rating -3A2

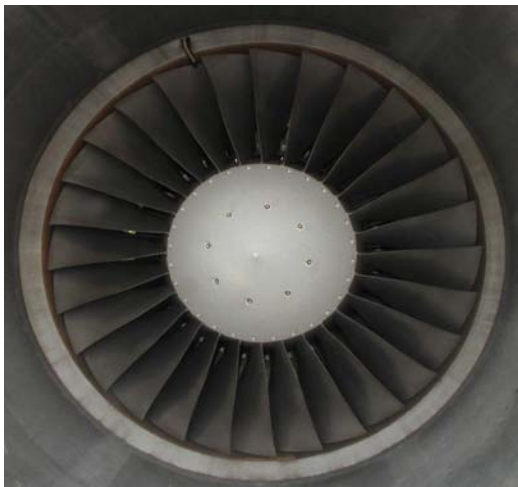
- Air Intake , Nose cone

No defects noted.

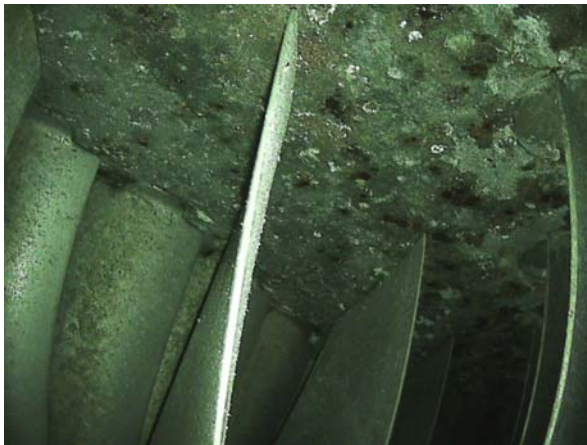
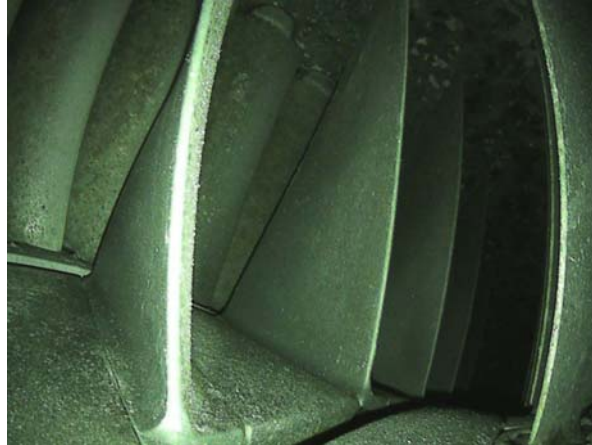
| Stage 1 | Dust and large amount of Moisture Observed | H.O |
| Compressor | 1 TE Blade / 1 LE Blade | |

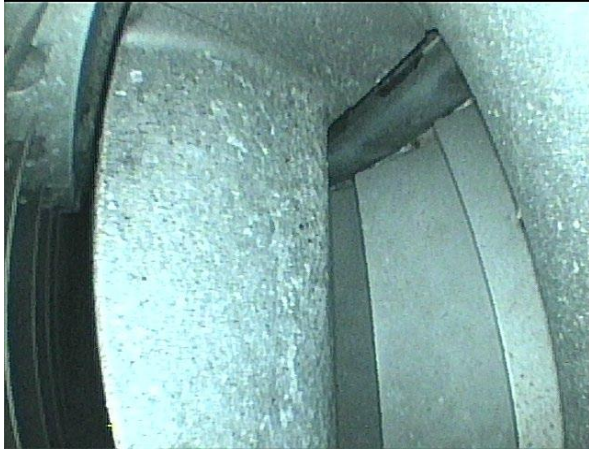
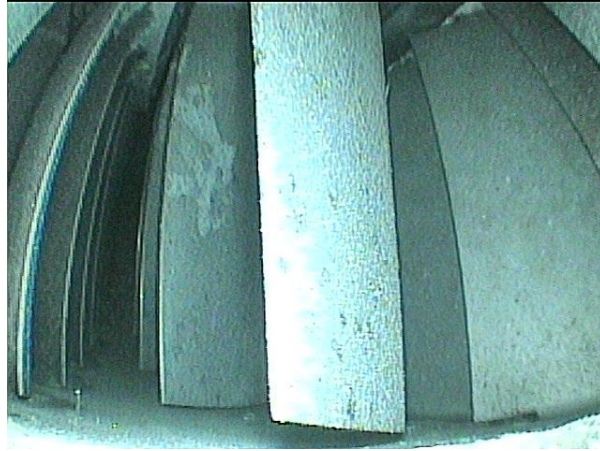
| <b>Location área</b><br><b>Stage 2</b><br>Compressor | <b>Findings : Findings :</b> No Damage found<br>Dust observed<br>2 TE Blade / 2 LE Blade | <b>Sig.</b><br>H.D |

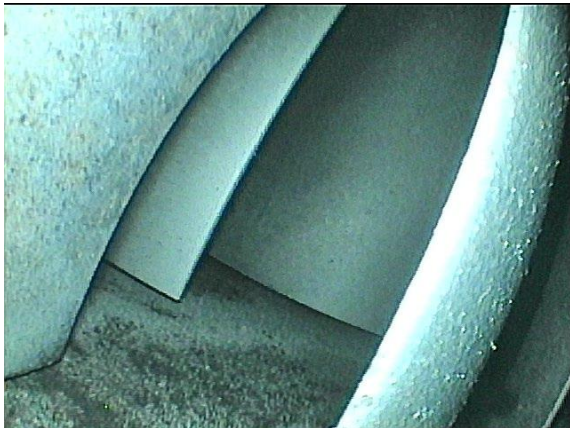
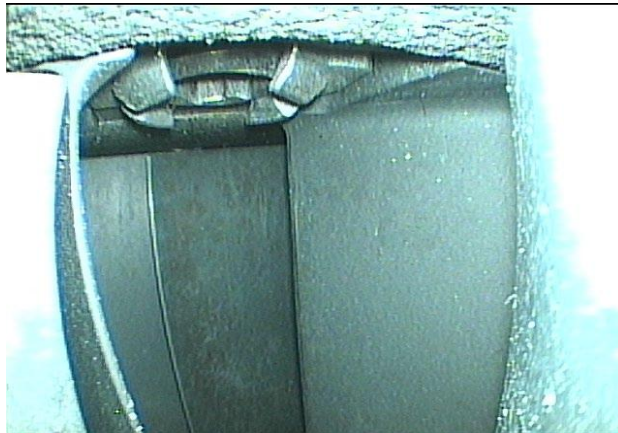
| <b>Location area</b><br><b>Stage 3</b><br>Compressor | <b>Findings : Findings :</b> NO DAMAGE FOUND<br>Dust observed<br>3 TE Blade / 3 LE Blade | <b>Sig.</b><br>H.D |

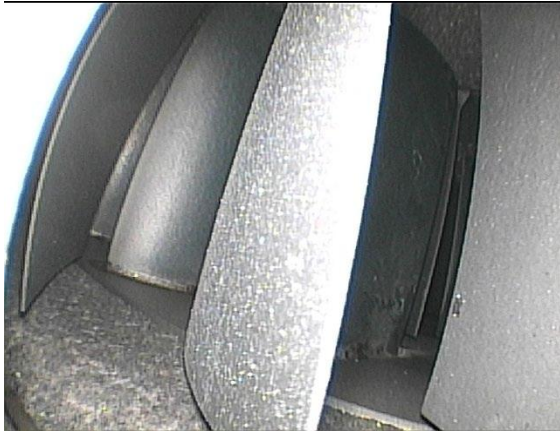
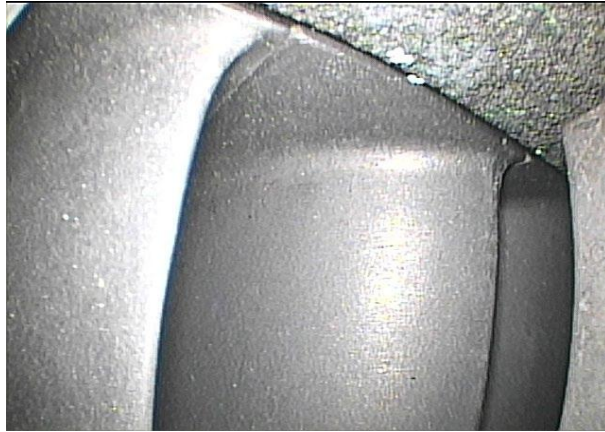
| <b>Location area</b><br><b>Stage 4</b><br><b>Compressor</b> | <b>Findings :</b> Findings : All findings are satisfactory<br><b>Findings :</b> No damage found<br>Dust observed<br>4 TE Blade / 4 LE Blade | Sig.<br><br>H.D |

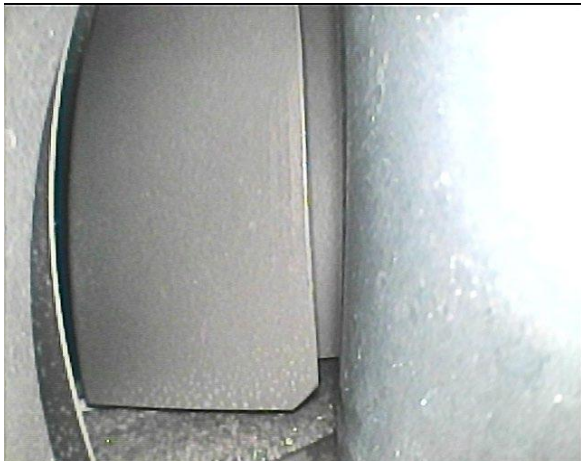
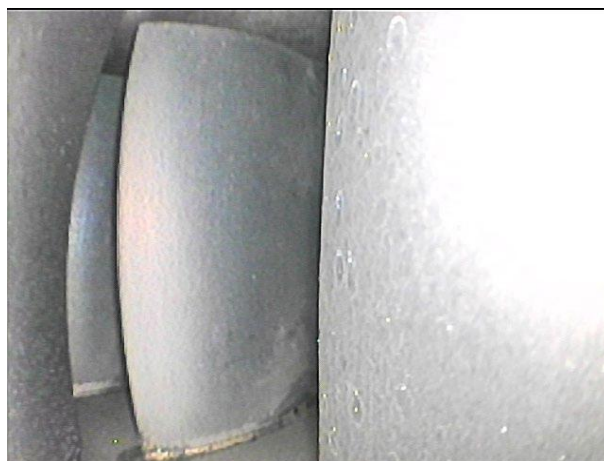
| <b>Location area</b><br><b>Satge 6</b><br><b>Compressor</b> | <b>Findings :</b> No damage found<br>Dust observed<br>6 TE Blade / 6 LE Blade | Sig<br><br>H.D |

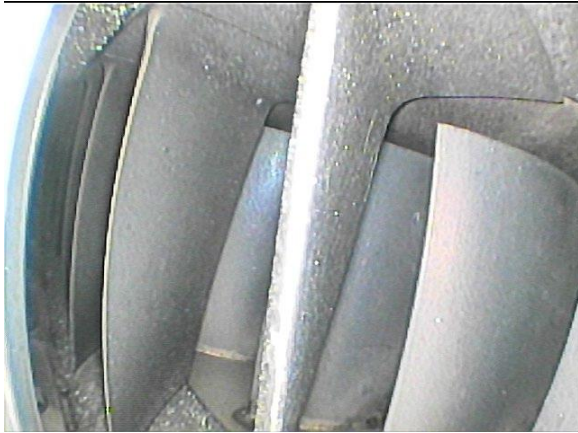
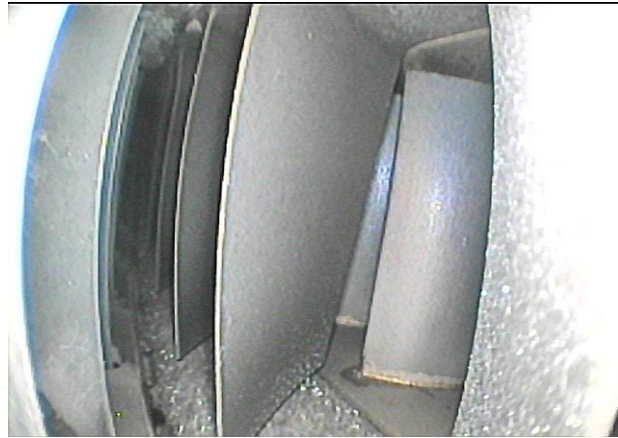
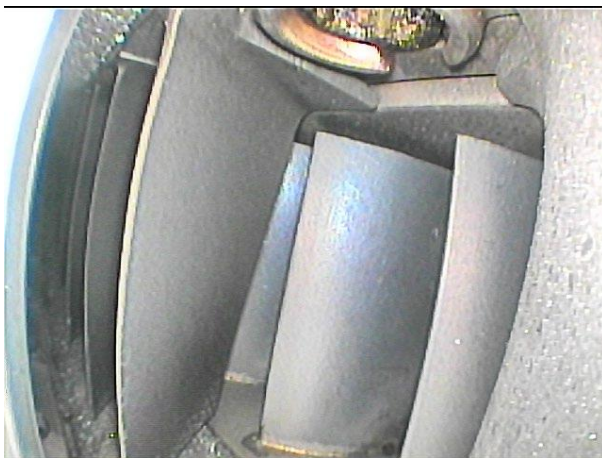
| <b>Location area</b><br><b>Satage 7</b><br>Compresor | <b>Findings:</b> No Damage Found<br>No damage found on:<br>7 LE Blade / 7 TE Blade | Sig<br><i>H.D</i> |

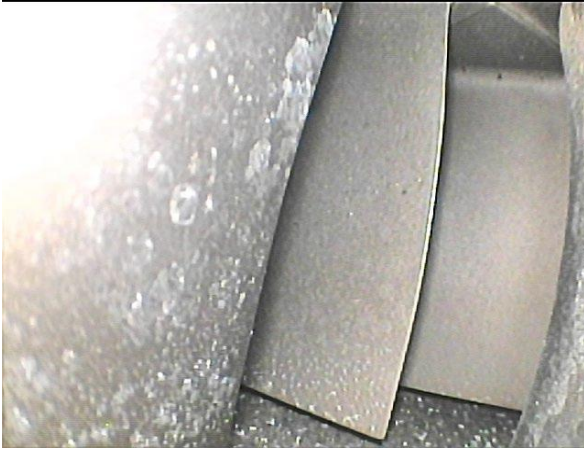
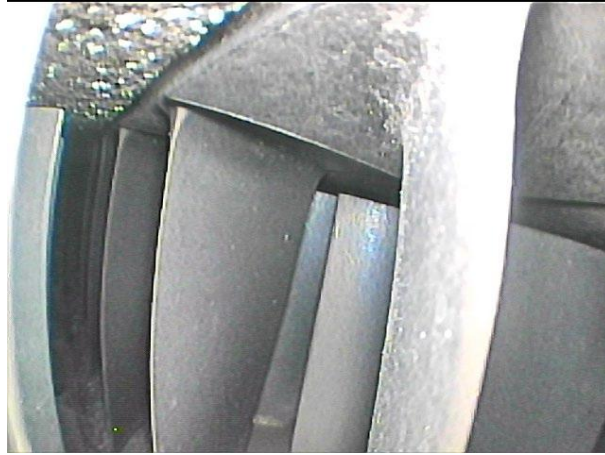
| <b>Location area</b><br><b>Stage 8</b><br>Compressor | <b>Findings :</b> No damage Found<br>Dust and Moisture Observed<br>8 TE Blade / 8 LE Blade | <b>Sig</b><br>H.D |

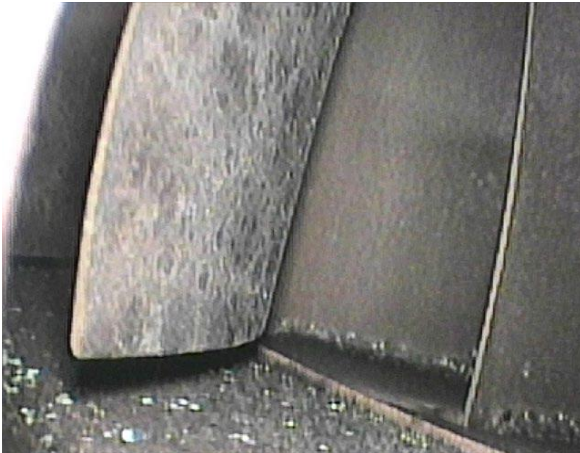
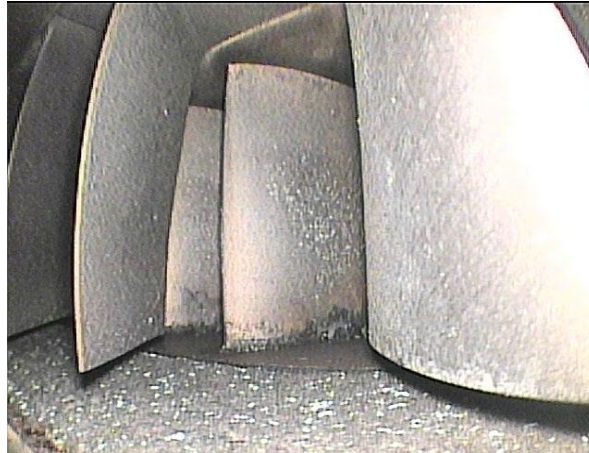
| <b>Location area</b><br><b>Stage 9</b><br>Compressor | <b>Findings :</b> All findings are satisfactory<br>Dust and Moisture Observed<br>9 TE Blade / 9 LE Blade | <b>Sig</b><br>H.D |

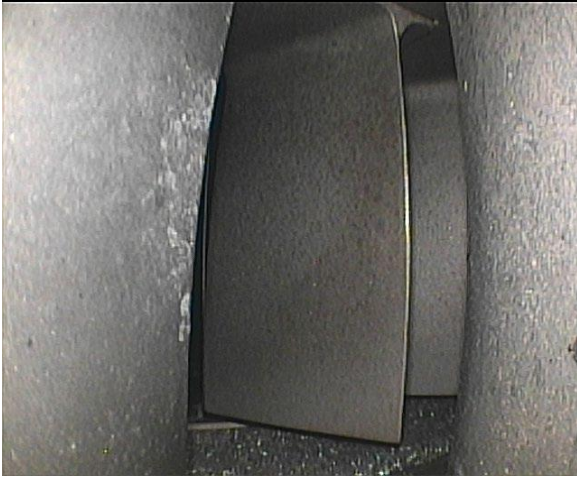
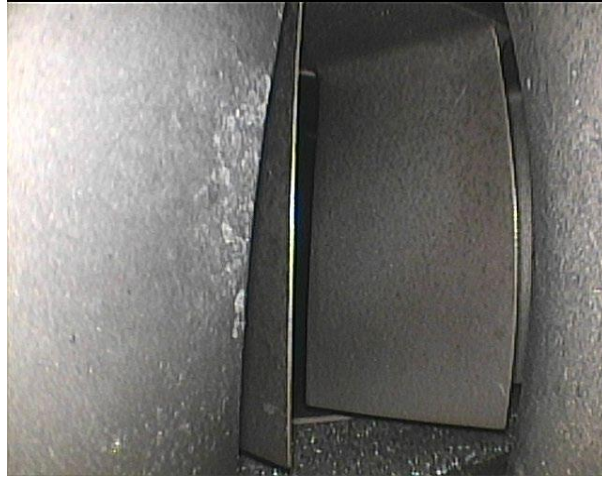
| <b>Location area</b><br><b>Stage 10</b> | <b>Findings :</b> No Damage found<br>Dust and Moisture Observed<br>10 TE Blade / 10 LE Blade | <b>Sig</b><br><i>H.O</i> |

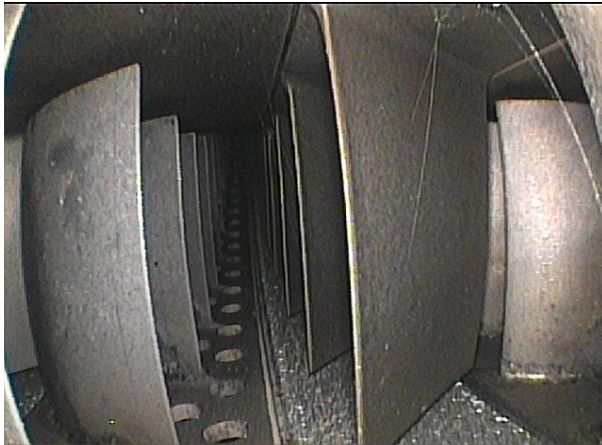
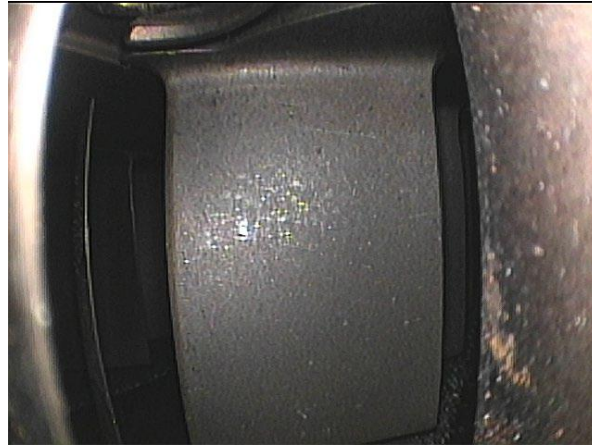
| <b>Location área</b><br><b>Satge 11</b> | <b>Findings :</b> All findings are satisfactory<br>Dust and Moisture Observed<br>11 TE Blade / 11 LE Blade | <b>Sig</b><br><i>H.O</i> |

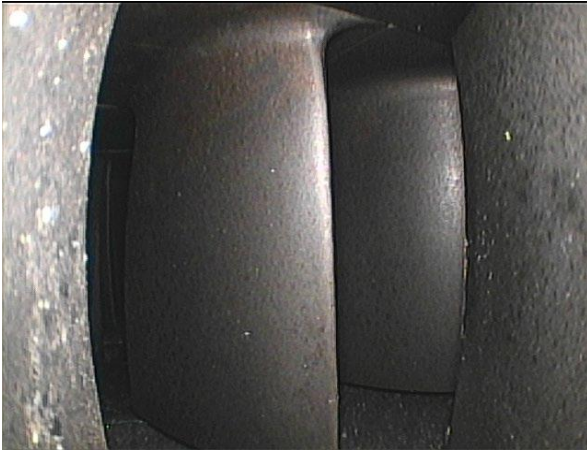
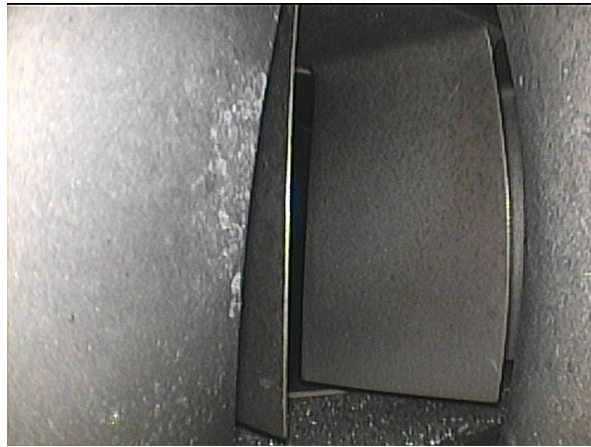
| <b>Location área</b><br><b>Satge 12</b> | <b>Findings :</b> No damage found<br>Dust and Moisture Observed<br>12 TE Blade / 12 LE Blade | <b>Sig</b><br><i>H.D</i> |

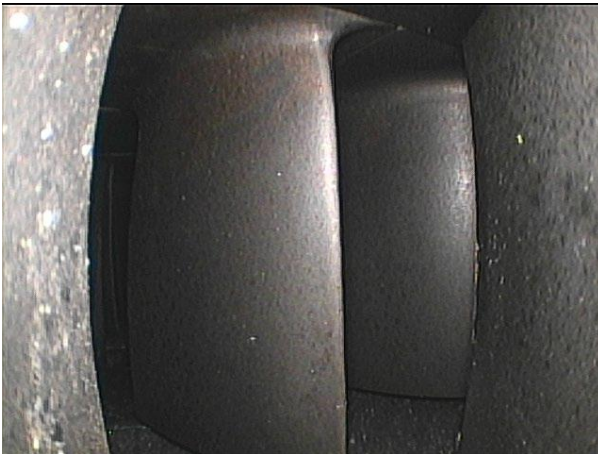
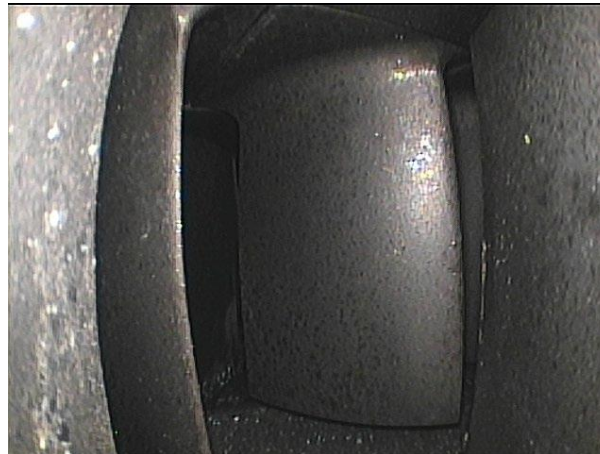
| <b>Location área</b><br><b>Satge 13</b> | <b>Findings :</b> All findings are satisfactory<br>Dust and Moisture Observed<br>13 TE Blade / 13 LE Blade | <b>Sig</b><br><i>H.D</i> |

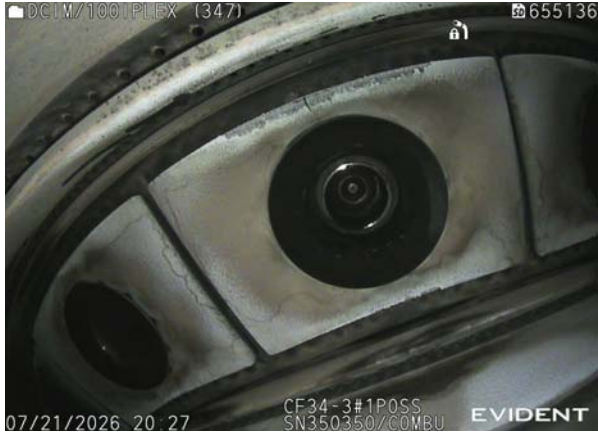
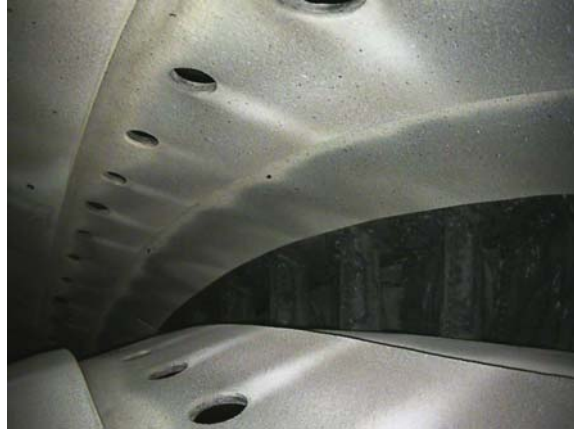
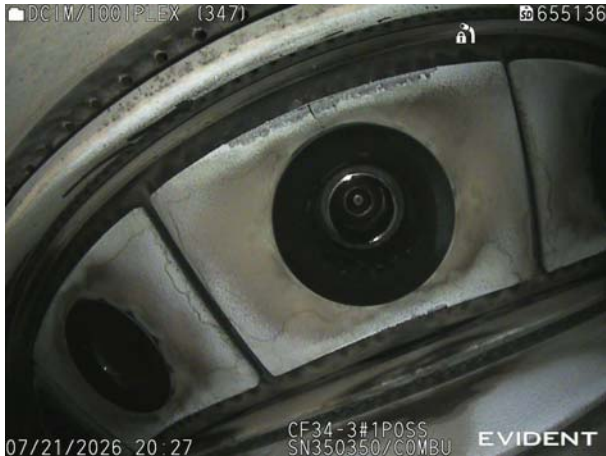
| <b>Location area</b><br><b>Sateg :</b><br><b>Comb Chamber</b> | <b>Findings</b> No Damage Found<br>Very small cracks on the edges of the fuel nozzle baffle.<br>IN LIMITS | <b>Sig</b><br>H.O |

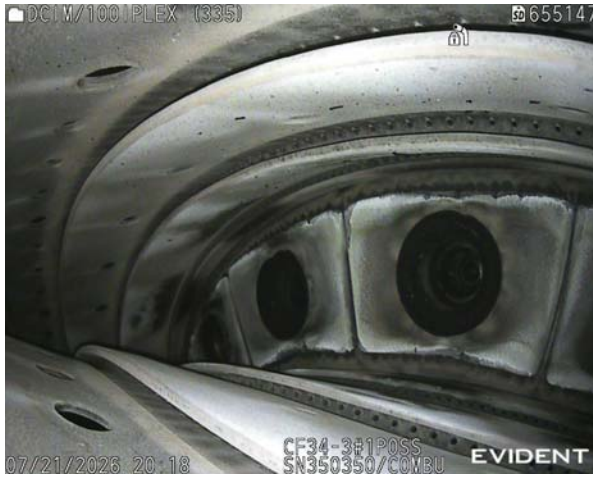
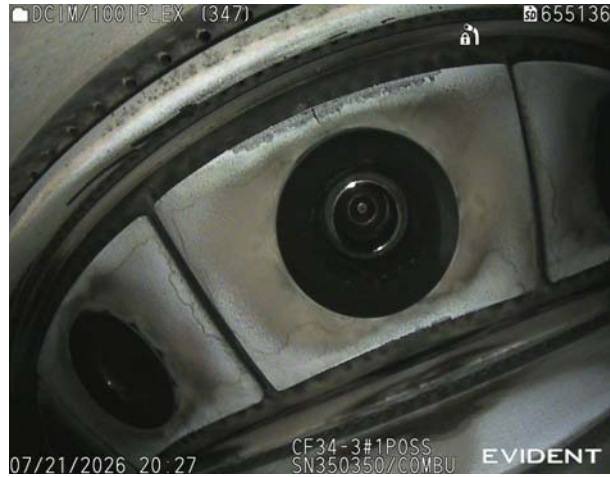
| <b>Location area</b><br><b>Satge:</b><br><b>Comb Chamber</b> | <b>Findings:</b> Light Burns on Baffles IN LIMITS<br><br>Small burns on all around baffle edge, normal damage. | <b>Sig</b><br><br>H.D |

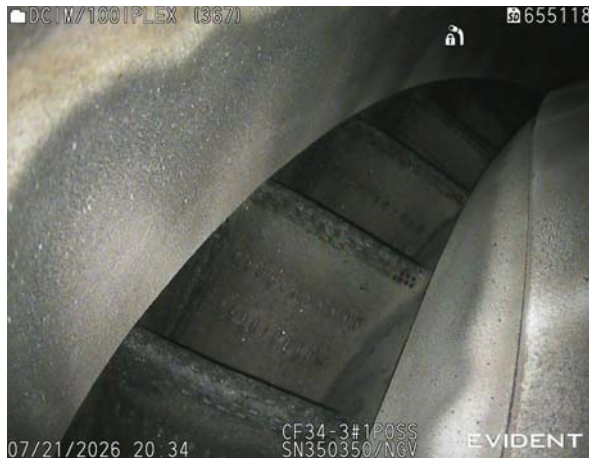
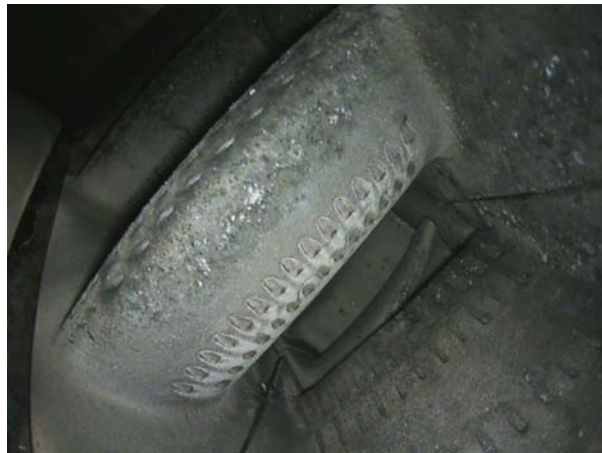
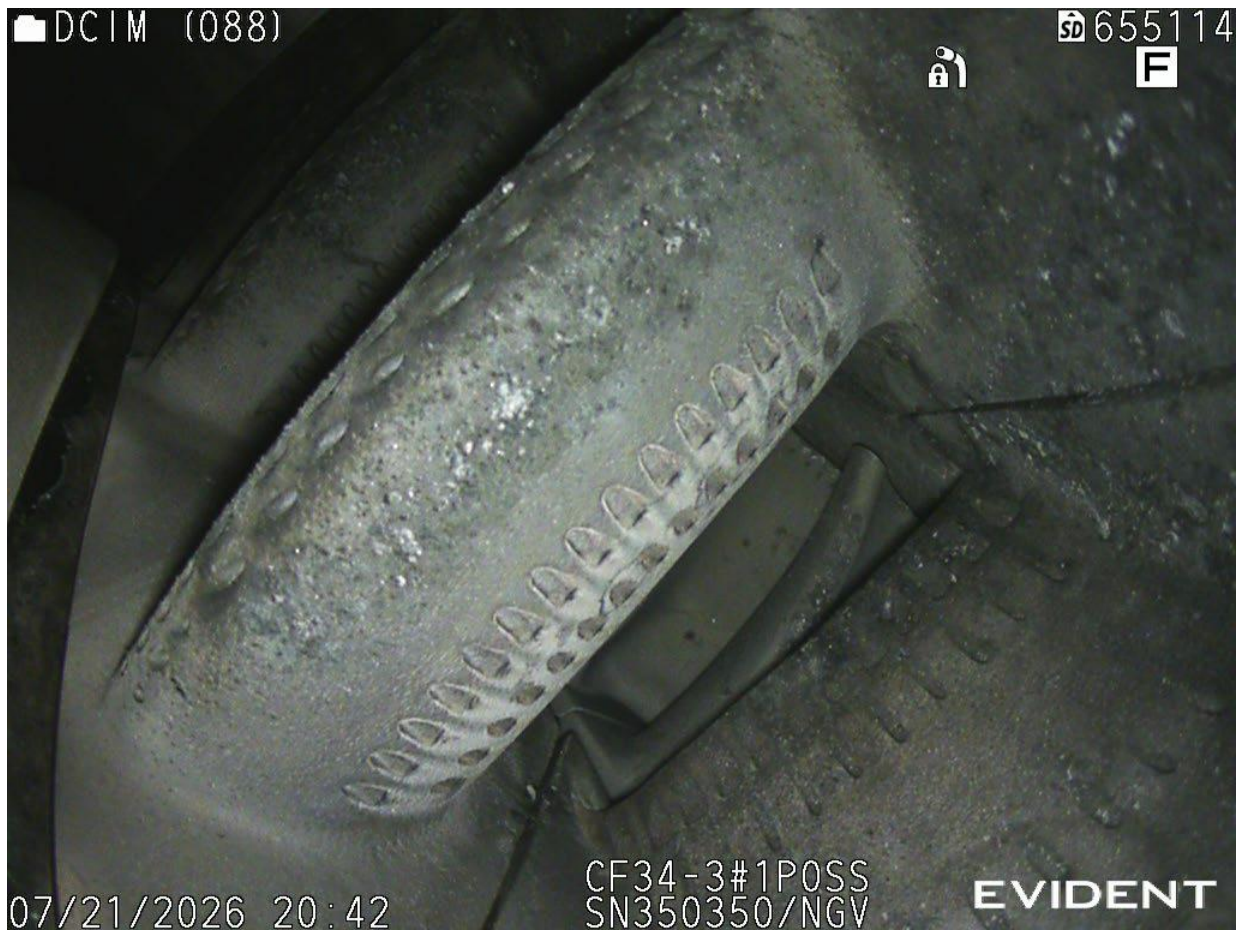
| <b>Location área</b><br><b>Stage</b><br><b>NGV</b> | <b>Findings :</b> No Damage Found<br>No burns ,no missing material on convex and concave sides | <b>Sig</b><br><i>H.D</i> |

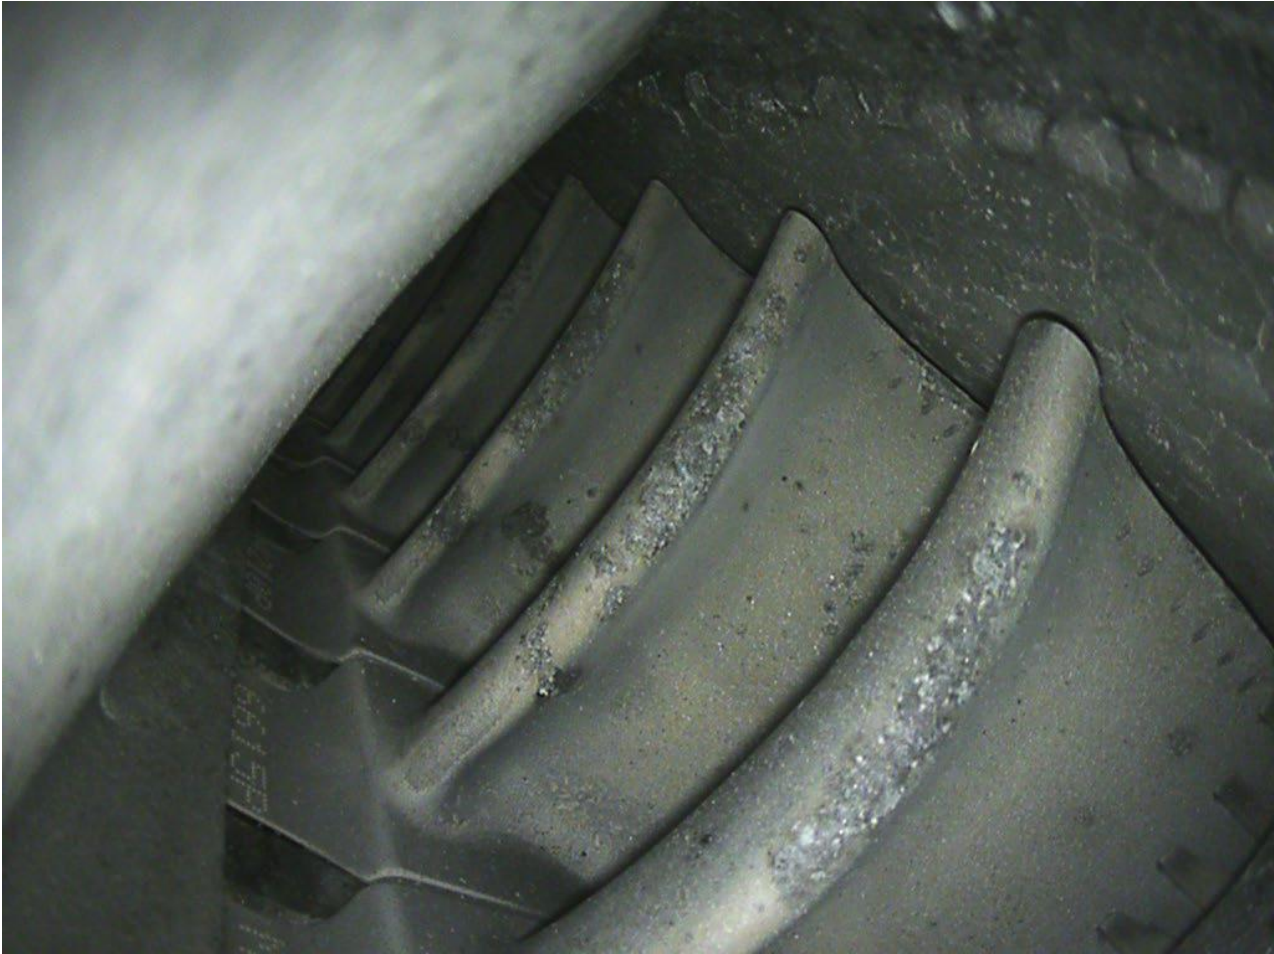
| <b>Location area</b><br><b>Satge:</b><br><b>HPT -1</b> | <b>Findings :</b> No Damage Found on HPT 1 Blades ,<br><br>No burns no cracks no missing material IN LIMITS | <b>Sig</b><br><i>H.D</i> |

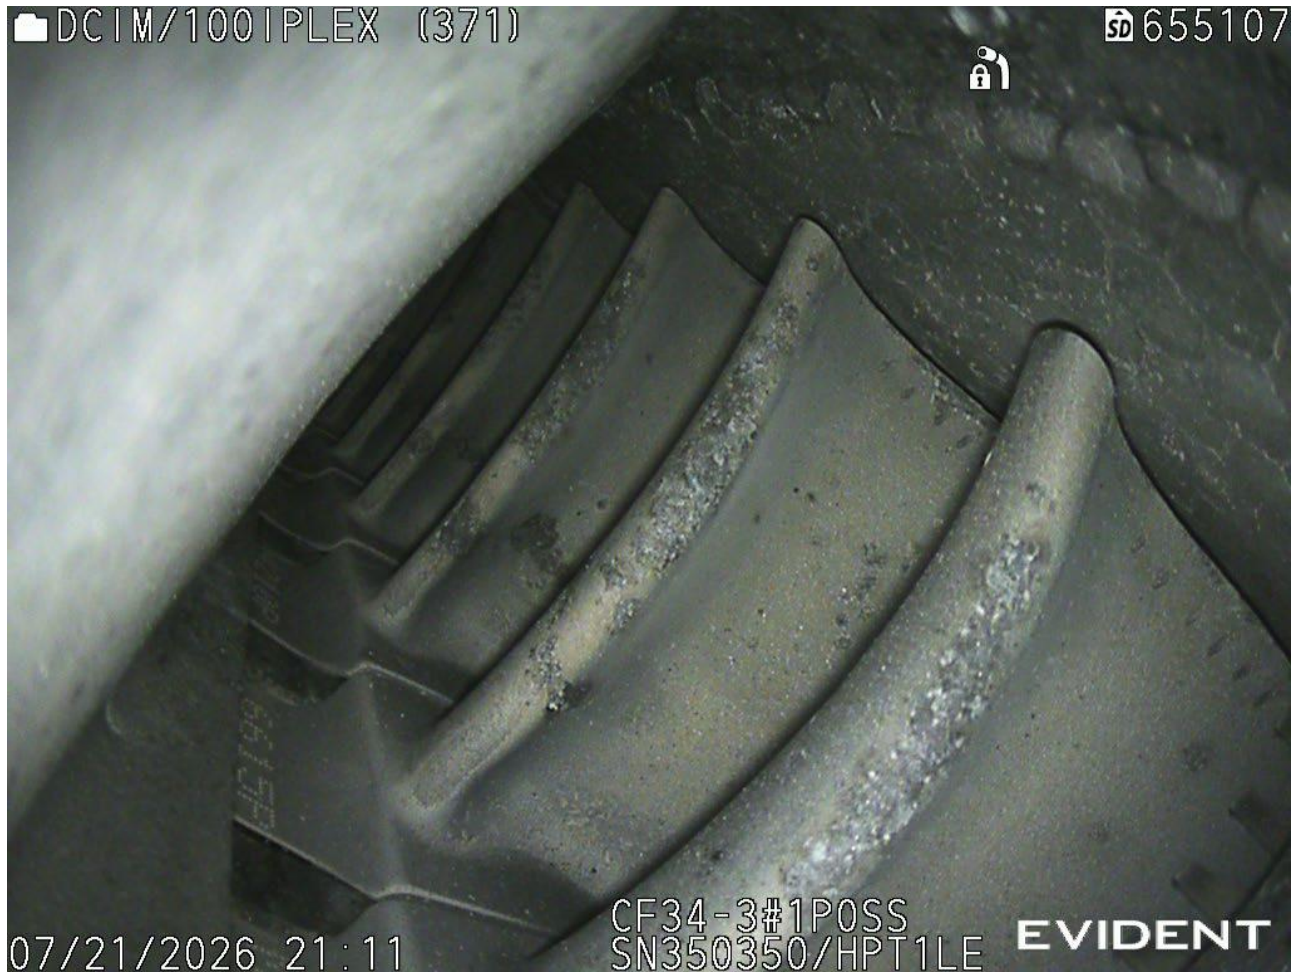
| <b>Location area</b><br><b>Satge T1</b> | <b>Findings:</b> No Damage Found on HPT 1<br><br>No Burns , no cracks , no missing material . IN LIMITS | <b>Sig</b><br><b>H.O</b> |
